Phase II Storm Water Pond Investigation

Conducted: Fall 2011

Purpose: In the Spring of 2011 during a site visit for Phase II's Sarasota County Neighbor Grant application for its' Entrances, Rob Wright, Neighborhood Environmental Stewardship Team (NEST) Program Coordinator for Sarasota County, noted that the bank of our storm water pond had receded/dropped some 6 to 8 feet. This information spurred the Phase II Grounds Committee to initiate an investigation into the history behind the pond, to determine if Mr. Wright's assumption was correct, and to establish a course of corrective action.

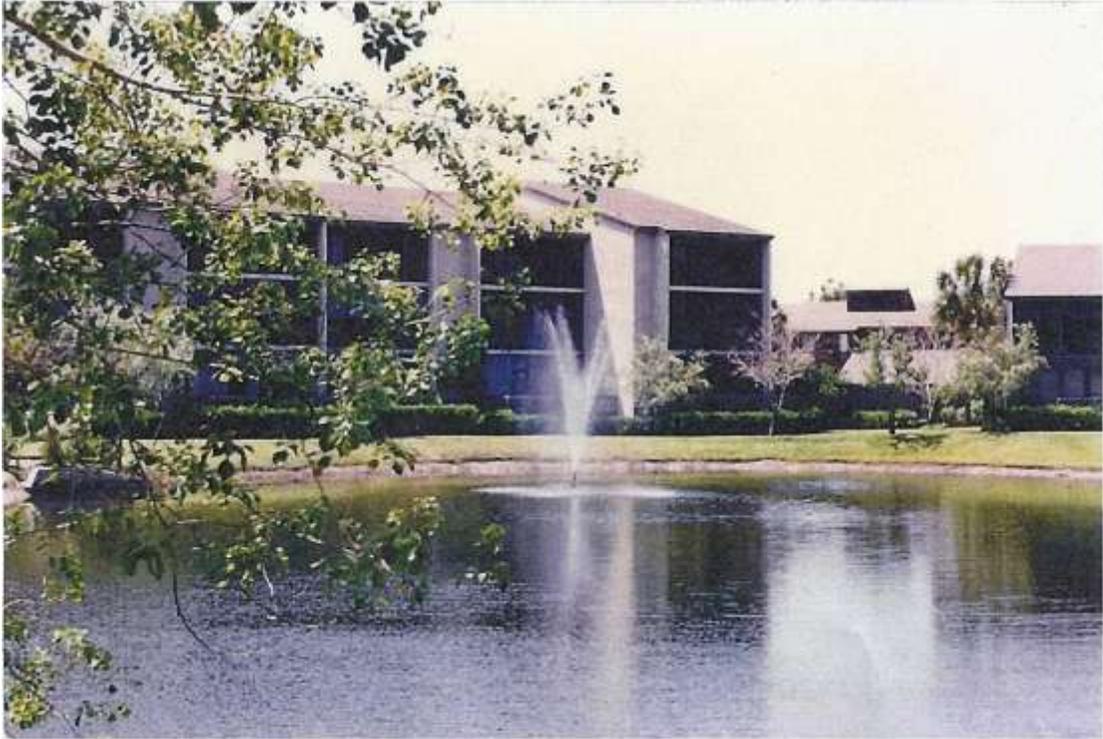
1. The Grounds Committee began by reviewing the historical documents and photos housed in the Bird Bay Library. Two photos from 1988 were found of the storm water pond (Fig 1). These photos indicated that at that time, there appeared to be a gentle slope from the land into the water. Likewise it was determined from the photo that the distance from the decks on the back of Building 29 to the water was greater than the distance in 2011(Fig 2). So it appears that Mr. Wright may be correct. This information was presented at a Phase II meeting.

Fig 1 - Phase II Pond as seen in 1988

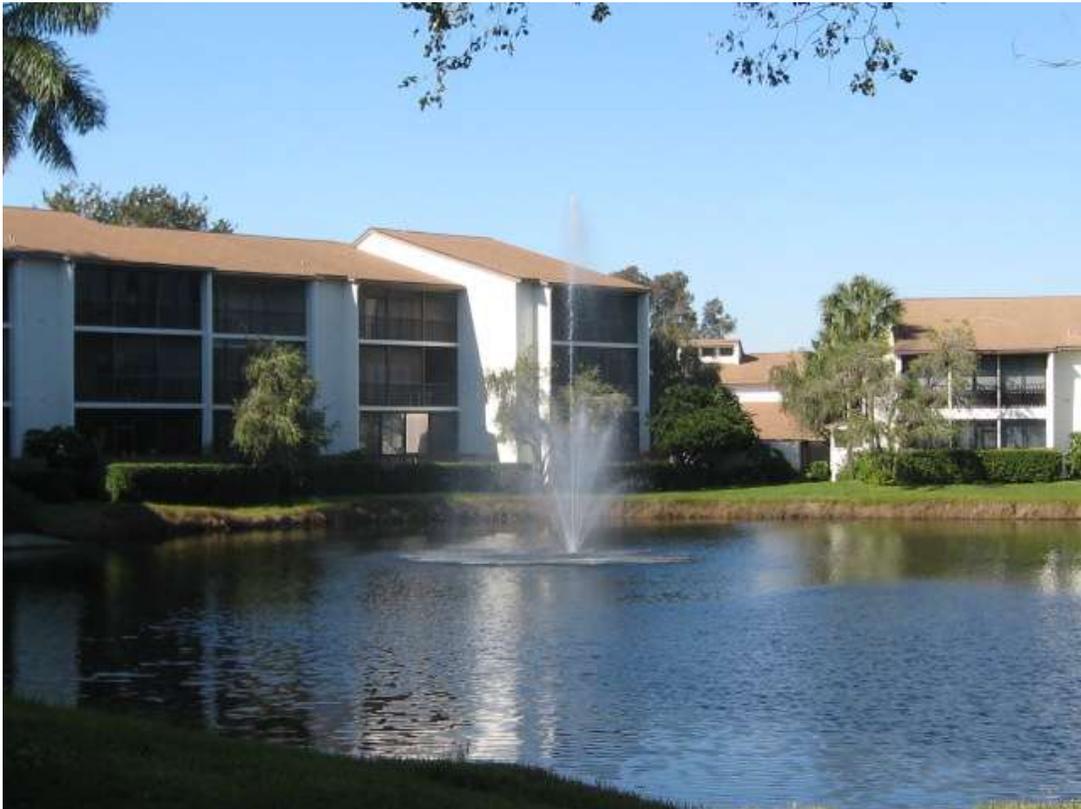
Fig 2 - Phase II Pond as seen in 2011

It is the recommendation of this group to install geo-tubing around the bank of Phase II's pond at least in the vicinity of Building 29. While the installation and stabilization for this section is considered immediate, the Phase may want to consider the stabilization of the rest of the banks of the pond in the future. The committee recommends that small areas such as around the head walls of the inlet culverts be planted with aquatic and semi-aquatic plants to evaluate their usefulness in stabilization of the existing bank and their esthetic appeal. This has actually all ready begun in the summer of 2011. A no-mow-zone approximately 2-3 feet in width was established around the entire pond. The "Fuzzy Rim" was noticed to all of the unit owners around the pond. The theory behind this rim or increase height of grass is that grass roots are directly related to their blade length. If the roots are longer, they will be able to hold more soil and thus help stabilize the bank. In addition, the increase grass height also helps to decrease the amount of nutrients i.e. nitrogen and phosphorous, that may enter the pond via overland runoff. Likewise, by not mowing up to the water's edge, the amount of grass clippings (organic matter) is also reduced lowering the nutrient load in the pond.

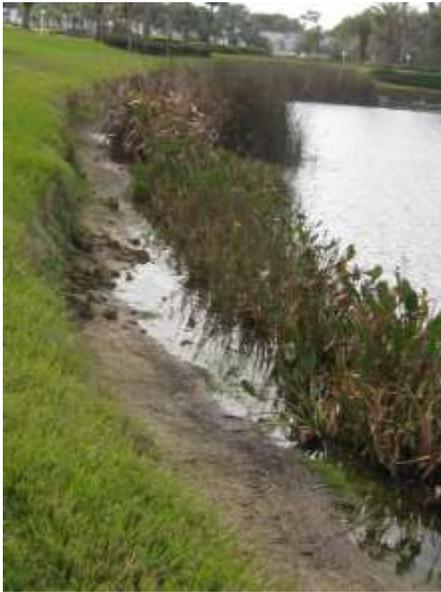
Waterford – Main Pond

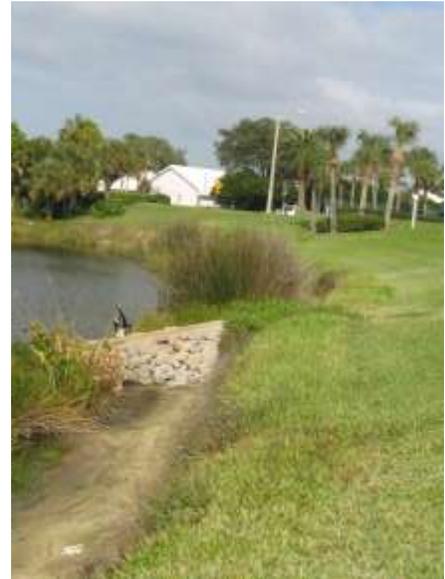
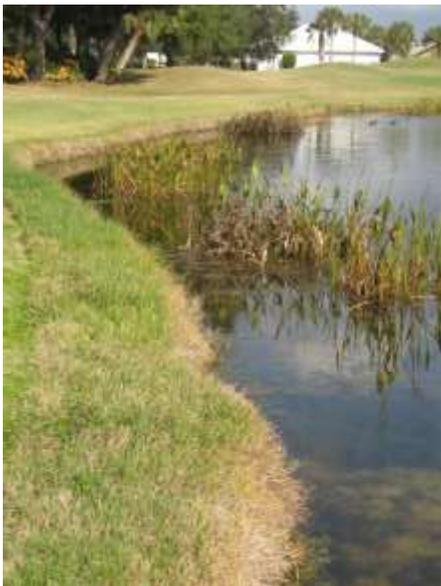
Waterford Golf Course Pond

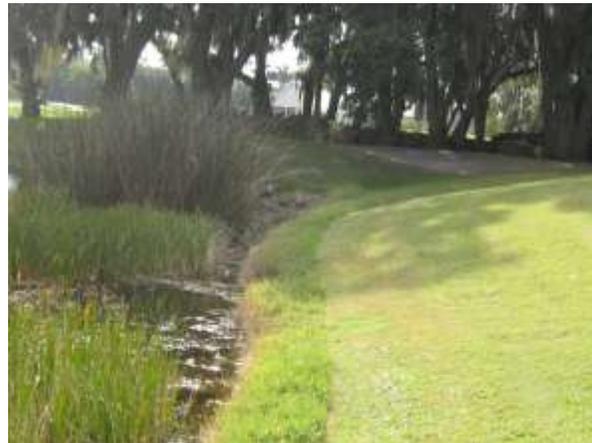
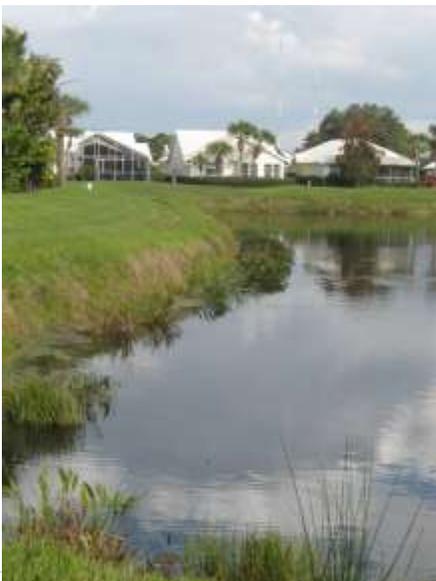
Waterford – Back Pond

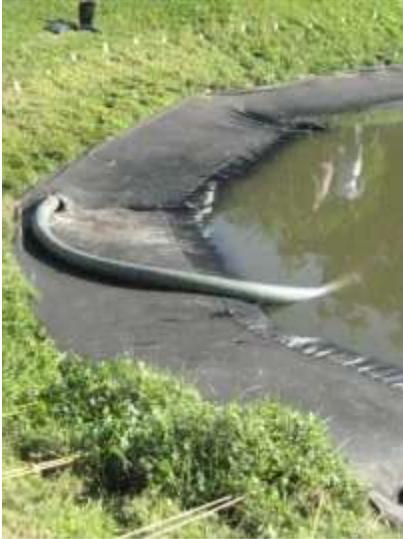
Plantation – Geo-tubing being filled. Note bag is staked to the shore. The first bag has a protective covering on the face to prevent damage from the sun and fish fins.

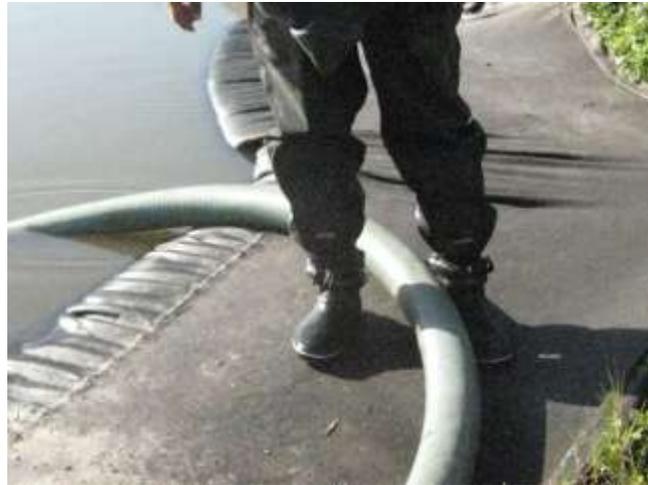
Plantation – Filled tubing – Note the firmness of the tube when filled.

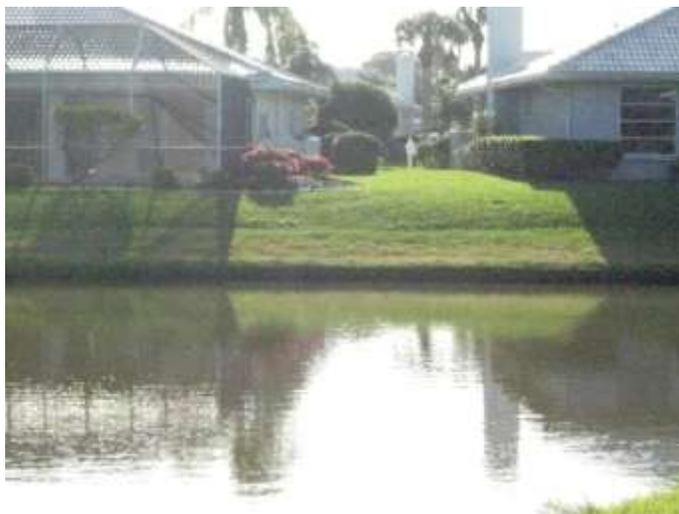
Plantation – Finished bank – Note line in grass: below is where the Geo-tubing was installed. Over time the line will disappear.

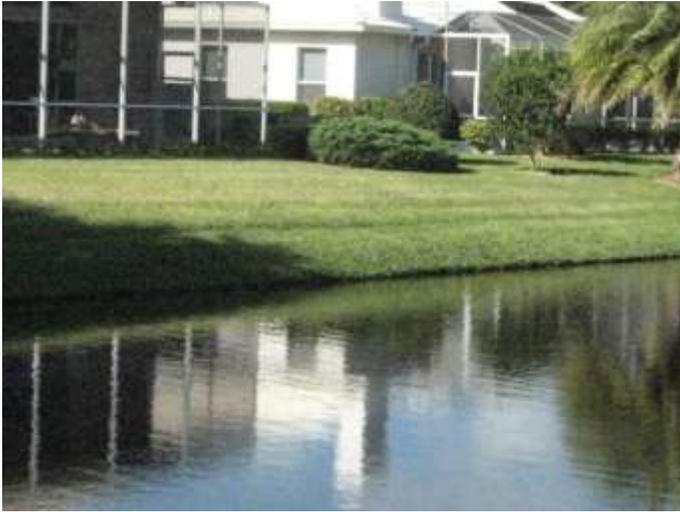
Venice Golf and Country Club – Finished Bank where Geo-tubing installed.

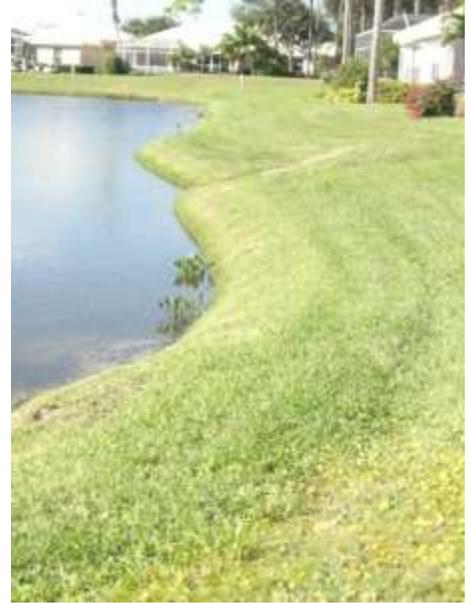
Venice Golf and Country Club – Finished Bank where Geo-tubing installed.

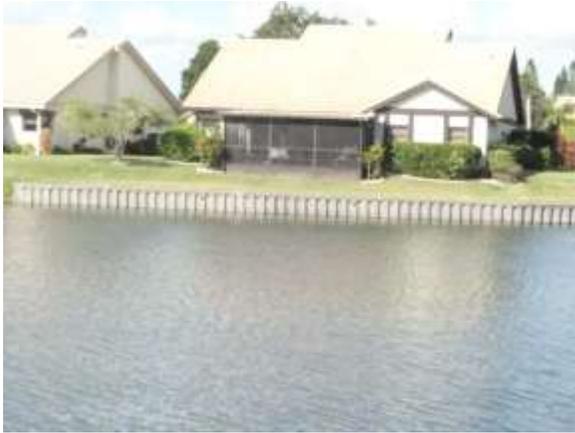
The Inlets – Corrugated retaining Wall

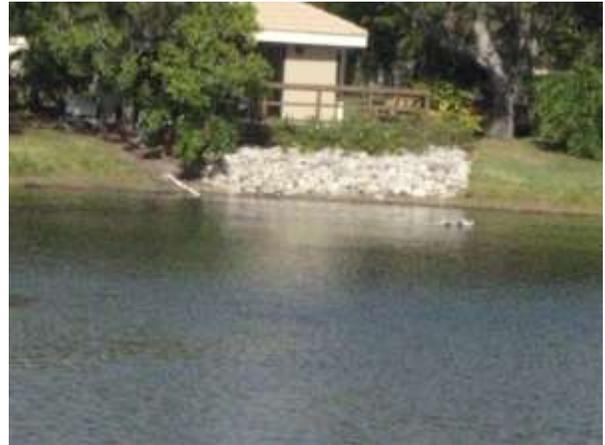
The Inlets – Area of Rip-Rap.

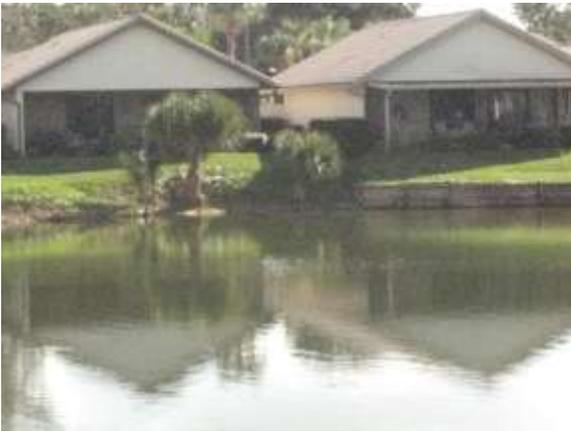
The Inlets – Area of wooden retaining wall and current state of erosion.

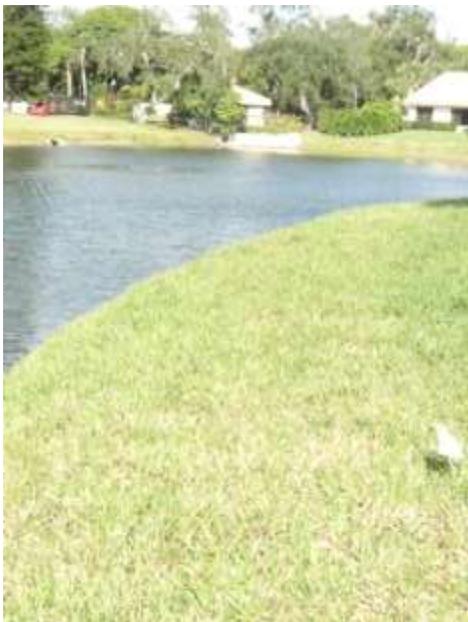
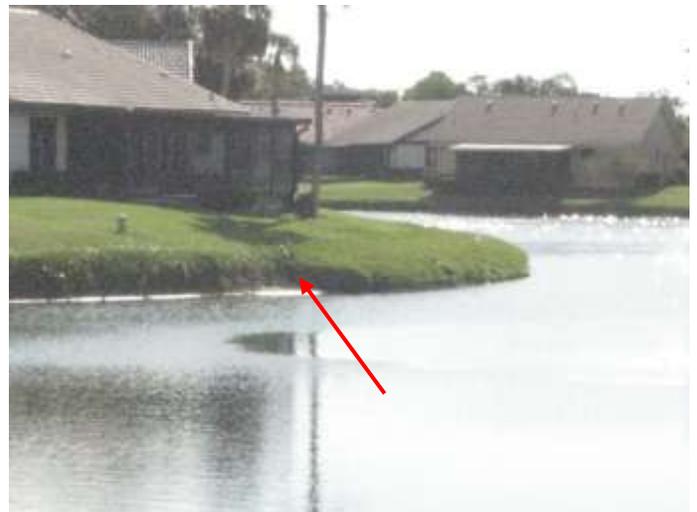
The Inlets – Finished bank after Geo-tubing installed. Note in the above picture the amount of bank recovered by the installation of the Geo-tubing.

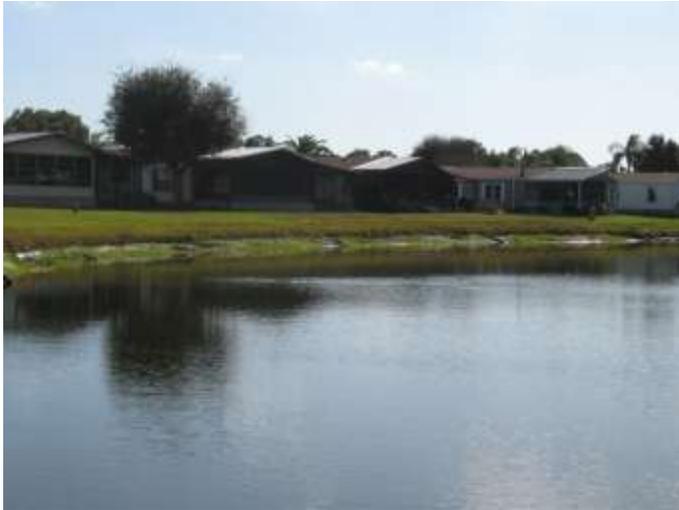
Tangerine Woods – Front Lake planted with Bahia grass and with a low lake level. Downspout drains and tubing can be seen.

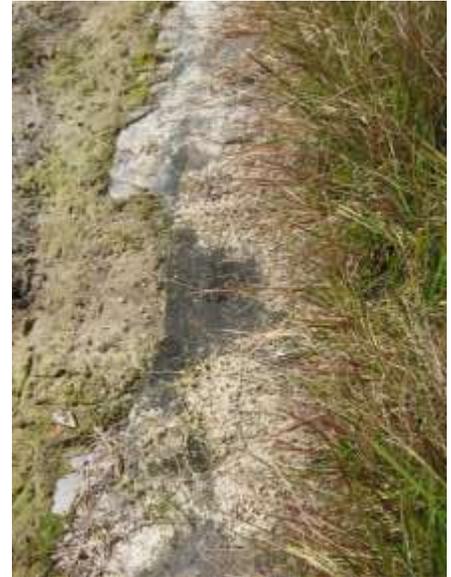
Tangerine Woods – Close up of tubing exposed due to low lake levels.

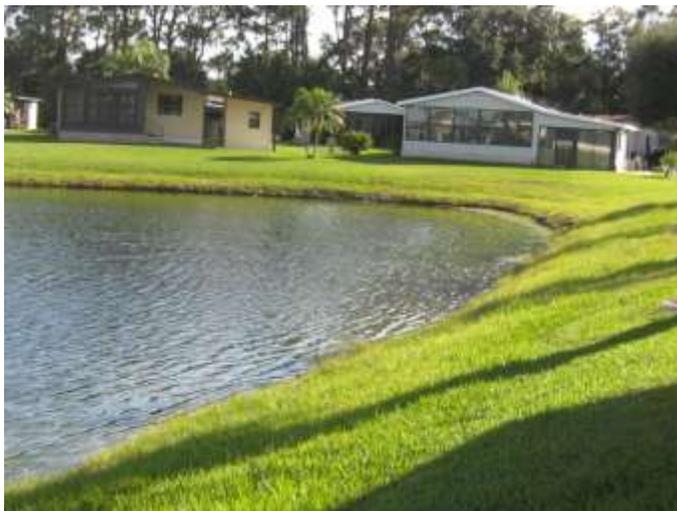
Tangerine Woods – Third Lake – Finished Bank after Geo-tubing installed.
