## Matheny Creek Condition Report for 2016

**Size:** 1,724 acres

**Location:** Central Sarasota County

**Discharges into:** Little Sarasota Bay

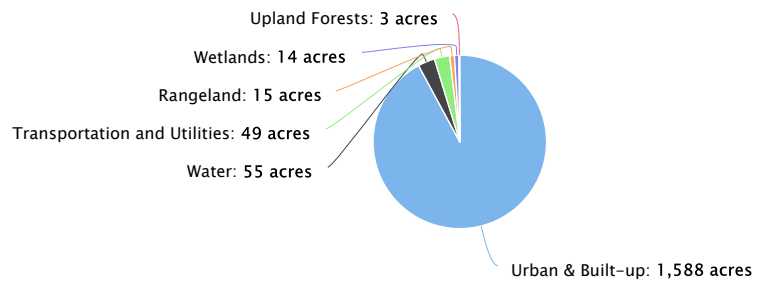
## 2011 Land Use / Land Cover within Matheny Creek Basin

Land use within a creek's watershed has a major effect on its water quality. In general, less development means better water quality. Land Cover/Land Use classifications categorize land in terms of its observed physical surface characteristics (e.g. upland or wetland), and also reflect the types of activity that are taking place on it (agriculture, urban/built-up, utilities, etc.). Florida uses as its standard a set of statewide classifications which were developed by the Florida Department of Transportation.
