## North Creek Condition Report for 2014

**Size:** 2,327 acres

**Location:** Central Sarasota County

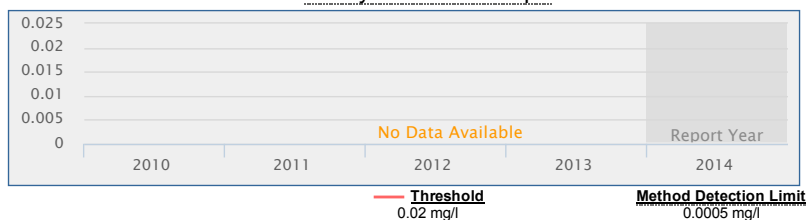
#### Chlorophyll a

Units: mg/l	Year 2014	Historical period of record
High		
Mean		n/a
Low		
No. of Samples

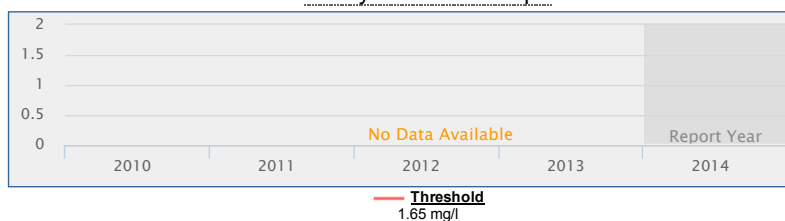
#### Nitrogen, Total

Units: mg/l	Year 2014	Historical period of record
High		
Mean		n/a
Low		
No. of Samples

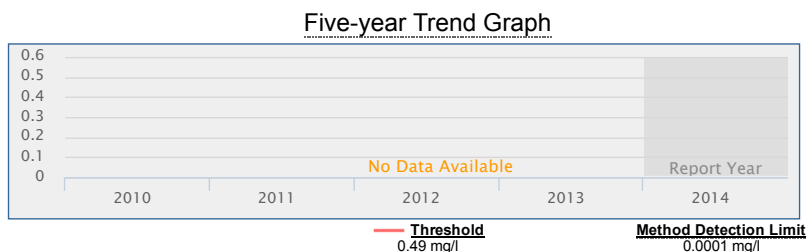
## Phosphorus, Total

Units: mg/l	Year 2014	Historical period of record
High		
Mean		n/a
Low		
No. of Samples

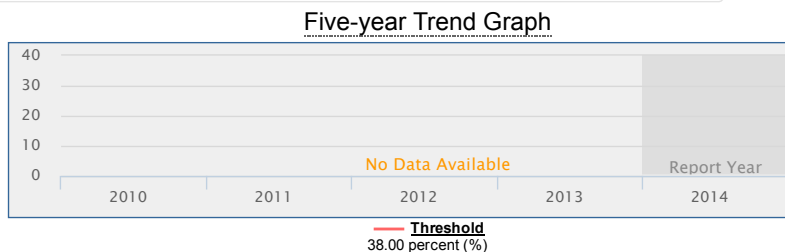
## Dissolved Oxygen Saturation

Note: Low DO saturation also may be naturally influenced by inflows from nearby wetlands or groundwater sources.

Units: percent (%)	Year 2014	Historical period of record
High		
Mean		n/a
Low		
No. of Samples

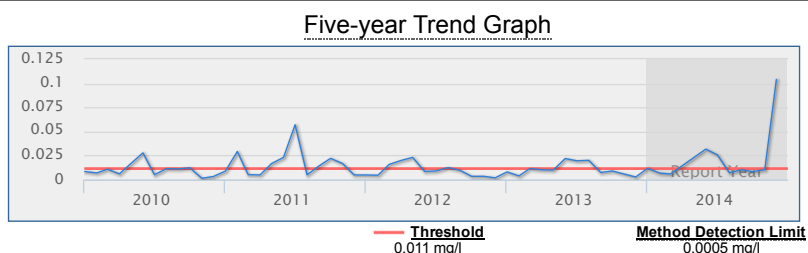
## Chlorophyll *a*

Score: **Caution**

Units: mg/l	Year 2014	Historical period of record
High	0.1	0.1
Mean	0.0137	n/a
Low	0.0057	0.0009
No. of Samples	10	131

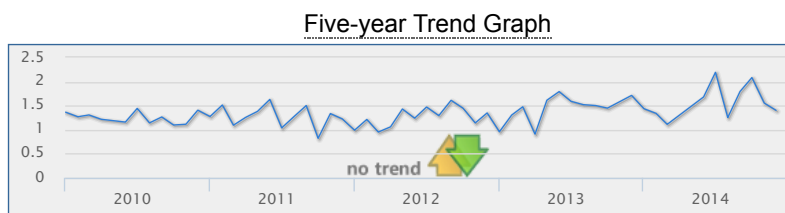
## Nitrogen, Total

Score: **Pass**

Units: mg/l	Year 2014	Historical period of record
High	2.2	2.3
Mean	1.5505	n/a
Low	1.111	0.16
No. of Samples	10	162

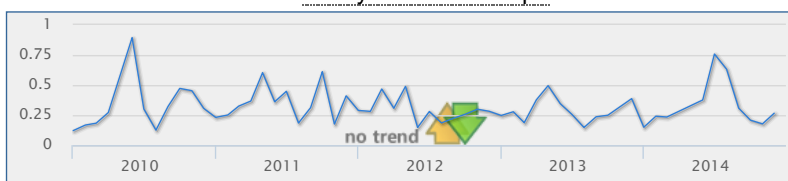
## Phosphorus, Total

Score: **Pass**

Units: mg/l	Year 2014	Historical period of record
<b>High</b>	0.8	0.9
<b>Mean</b>	0.2924	n/a
<b>Low</b>	0.149	0.08
<b>No. of Samples</b>	10	175

Method Detection Limit  
0.0001 mg/l

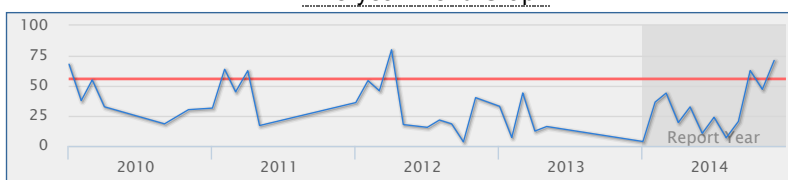
## Dissolved Oxygen Saturation

Note: Low DO saturation also may be naturally influenced by inflows from nearby wetlands or groundwater sources

Score: **Caution**

Units: percent (%)	Year 2014	Historical period of record
<b>High</b>	71.0	157.4
<b>Mean</b>	23.29	n/a
<b>Low</b>	3.60	1.50
<b>No. of Samples</b>	12	239

Threshold  
56.00 percent (%)

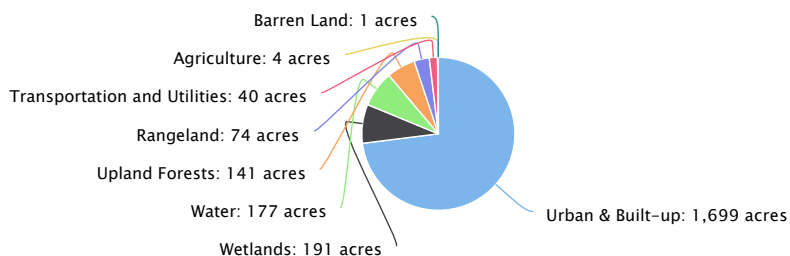
### 2011 Land Use / Land Cover within North Creek Basin

Land use within a creek's watershed has a major effect on its water quality. In general, less development means better water quality. Land Cover/Land Use classifications categorize land in terms of its observed physical surface characteristics (e.g. upland or wetland), and also reflect the types of activity that are taking place on it (agriculture, urban/built-up, utilities, etc.). Florida uses as its standard a set of statewide classifications which were developed by the Florida Department of Transportation.
