North Creek Condition Report for 2016

Size: 2,327 acres

Location: Central Sarasota County

Discharges into: Little Sarasota Bay

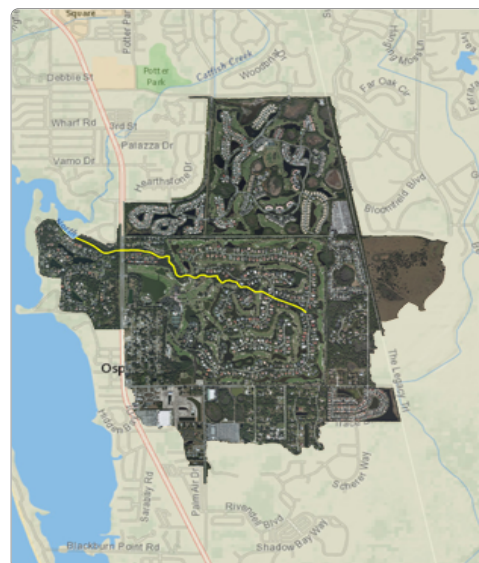
The surface water system in the North Creek Basin has undergone significant alteration over the past century. The 1847 General Land Office Survey shows North Creek extending from Little Sarasota Bay, east across the approximately 2½-mile-wide basin to what appears to be a pond. The 1959 USDA NRCS Soil Survey shows two north-south ditches leading to North Creek. The ditch to the south leads to an area in the west that appears to be a development. With the exception of the western boundary, U.S. 41, and some ditches, the basin was still fairly undeveloped by the 1970s. By 2000, roughly half of the basin was developed and about 1,930 people resided in the developed areas (U.S. Census Bureau, 2000). Today, about 75% of the basin is developed and laden with ditches and stormwater infrastructure, with half of the development residential. *For basin details see: [Little Sarasota Bay Water Quality Management Plan \(2012\)](#)*

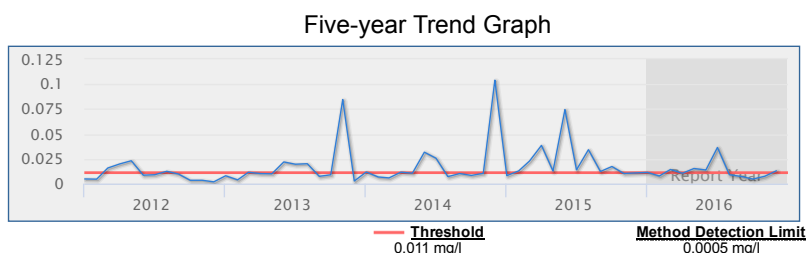
Chlorophyll *a*

Score: **Pass**

Units: mg/l	Year 2016	Historical period of record
High	0.0	0.1
Mean	0.0109	n/a
Low	0.0046	0.0009
No. of Samples	14	305

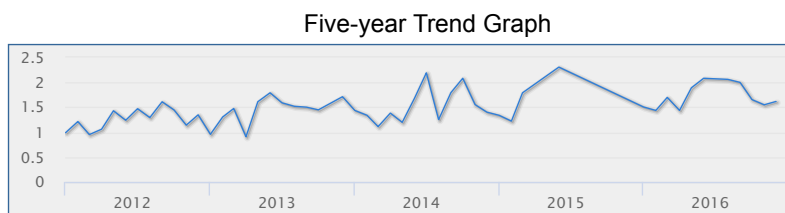
Nitrogen, Total

Units: mg/l	Year 2016	Historical period of record
High	2.1	2.3
Mean	1.7057	n/a
Low	1.436	0.16
No. of Samples	11	187

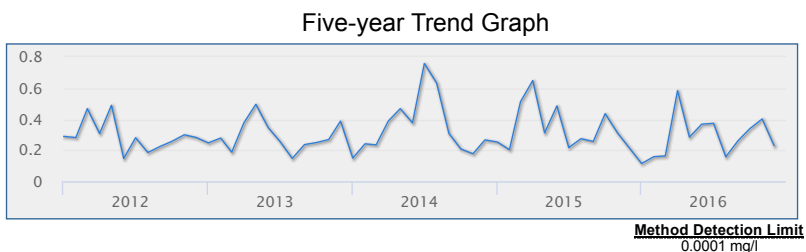
Phosphorus, Total

Units: mg/l	Year 2016	Historical period of record
High	0.6	0.9
Mean	0.2292	n/a
Low	0.114	0.08
No. of Samples	14	349

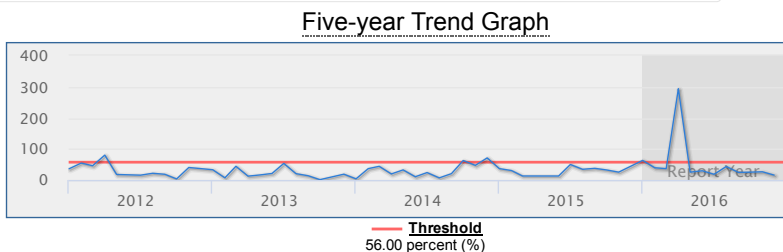
Dissolved Oxygen Saturation

Note: Low DO saturation also may be naturally influenced by inflows from nearby wetlands or groundwater sources

Score: **Caution**

Units: percent (%)	Year 2016	Historical period of record
High	293.4	293.4
Mean	38.41	n/a
Low	15.60	1.00
No. of Samples	14	406

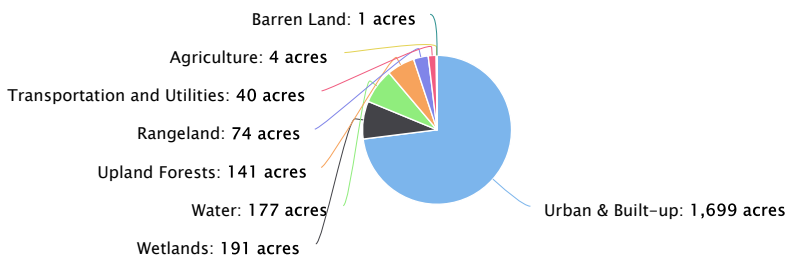
2011 Land Use / Land Cover within North Creek Basin

Land use within a creek's watershed has a major effect on its water quality. In general, less development means better water quality. Land Cover/Land Use classifications categorize land in terms of its observed physical surface characteristics (e.g. upland or wetland), and also reflect the types of activity that are taking place on it (agriculture, urban/built-up, utilities, etc.). Florida uses as its standard a set of statewide classifications which were developed by the Florida Department of Transportation.
