Palma Sola Bay Condition Report for 2017

Bays included in this report: Palma Sola Bay

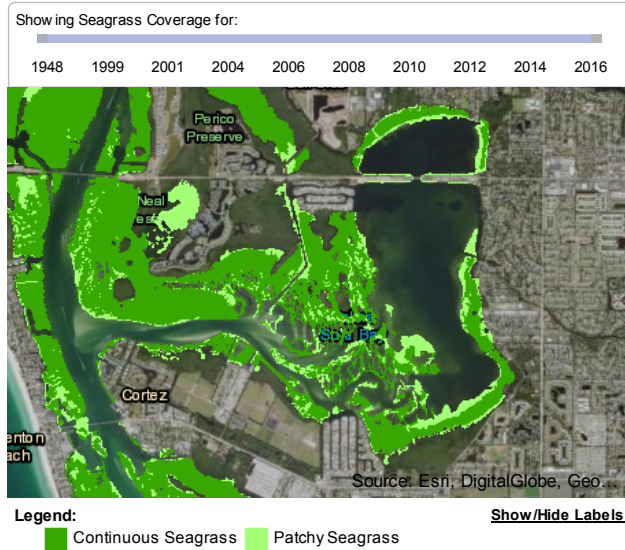
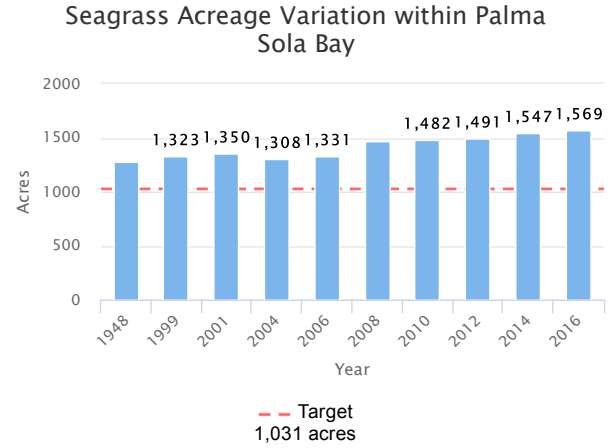
Seagrasses

Among the most important habitats in Florida's estuarine environments, seagrass beds are indispensable for the role they play in cycling nutrients, supplying food for wildlife, stabilizing sediments, and providing habitat for juvenile and adult finfish and shellfish. Use the interactive map below to observe the size, density and location of seagrass beds from year to year. The graph shows how the total amount of seagrass in the bay has changed over time.

Biotic Indicator: Measurement of the biotic indicator, seagrass, was last performed in 2016 by the Southwest Florida Water Management District. The total area of seagrass in Palm Sola Bay increased very slightly from the 2014 assessment and is now estimated to be 1,569 acres, one and a half times the target acreage of 1,031 acres.

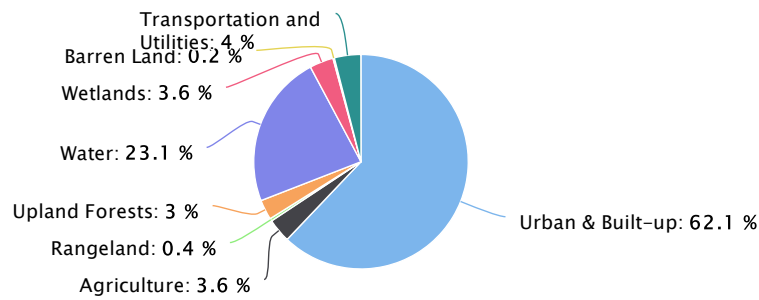
2011 Land Use / Land Cover for Sarasota Bay Watershed

Palma Sola Bay is located within the Sarasota Bay Watershed. The chart below shows the land use / land cover characteristics for Sarasota Bay Watershed within the boundary of this Water Atlas. [View details about the Sarasota Bay Watershed »](#)

as a percentage of land area for this watershed
