# County-Wide Survey of Sediment Quality at Weir Structures

## *Final Report*

PBSJ&J

**August 2003**

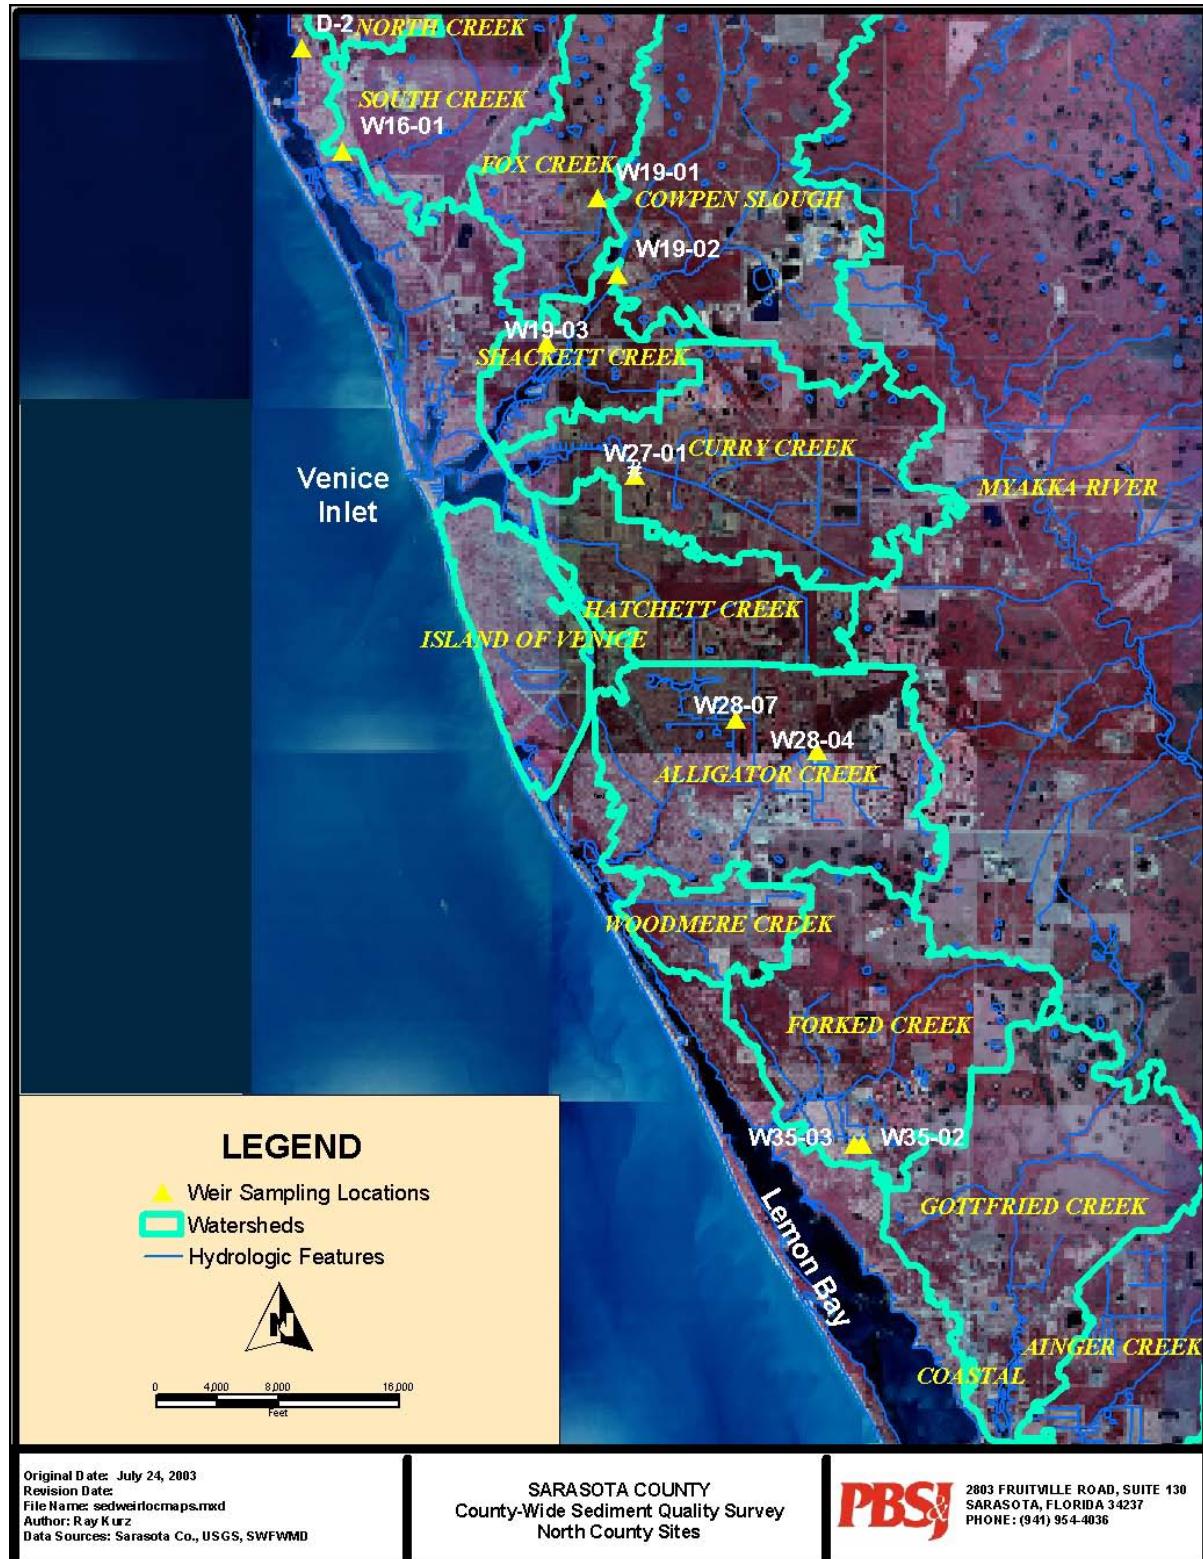
Figure 2-2. Map of sediment sampling locations in southern Sarasota County, Florida.
