# Hydrography of the Grand Canal and Heron Lagoon Waterways, Siesta Key, Florida

A REPORT  
ON  
THE HYDROGRAPHY AND BIOLOGY OF TWO MAN-MADE  
CANAL SYSTEMS - HERON LAGOON AND  
GRAND CANAL - ON SIESTA KEY  
SARASOTA COUNTY, FLORIDA<sup>1</sup>

Division of Natural Sciences, New College  
Sarasota, Florida

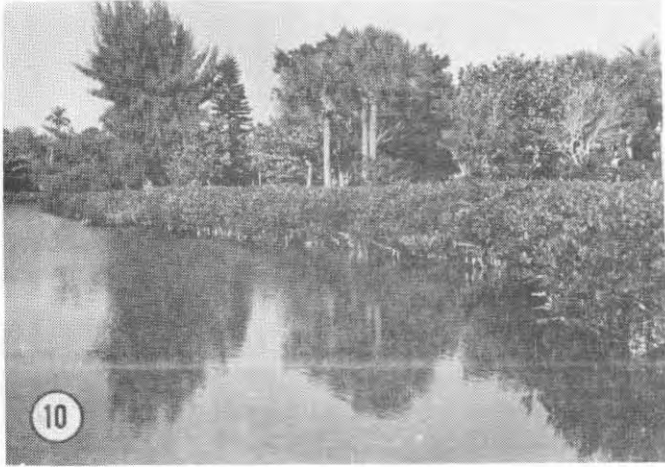
Figure 14 Seawalled canals, Siesta Isles, Grand Canal.  
Note the narrow barnacle-oyster zone on the  
seawall in the lower left foreground.

Grand Canal. The Grand Canal system of some 9 miles of waterways has 89 acres of water surface. Over 13 miles of canal banks are sea walled (Figs. 14, 15 & 18) while 5 miles are vegetated with native or cultivated plants. Here again weedy species of ornamentals have grown into the canals (Figs. 16 & 17).

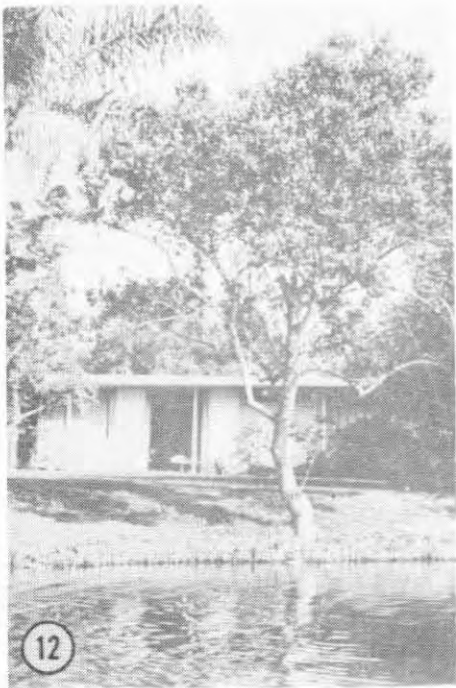
Figure 15 Sea walled canal, Siesta Isles.

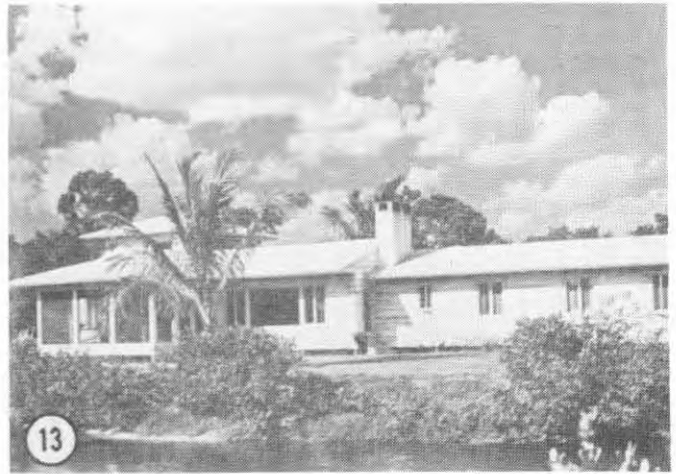
Figure 16 Palm Island section of canal with overgrowths  
of shore vegetation south of Calle Florida  
bridge.

As in Heron Lagoon, ornamental and native plant litter is a hidden pollution factor in the Grand Canal System. In parts of the Palm Island Circle Canal the Brazilian pepper trees have overgrown the canal margins. (Fig. 16).

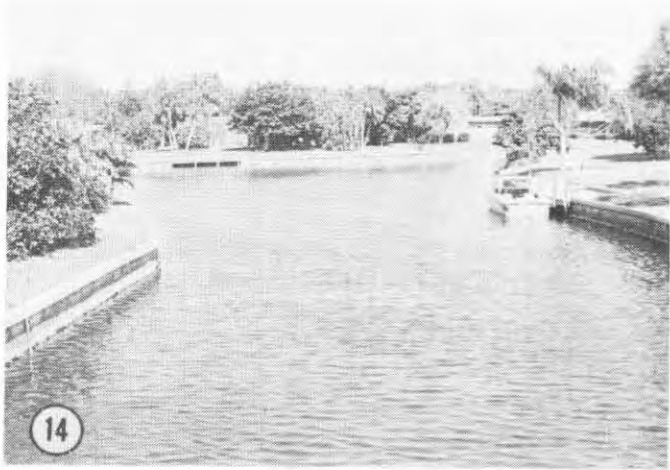
Figure 17 Palm Island canal, non sea walled section,  
looking north from Calle Florida bridge.  
The overgrowth of shore vegetation is pri-  
marily Brazilian pepper bushes.

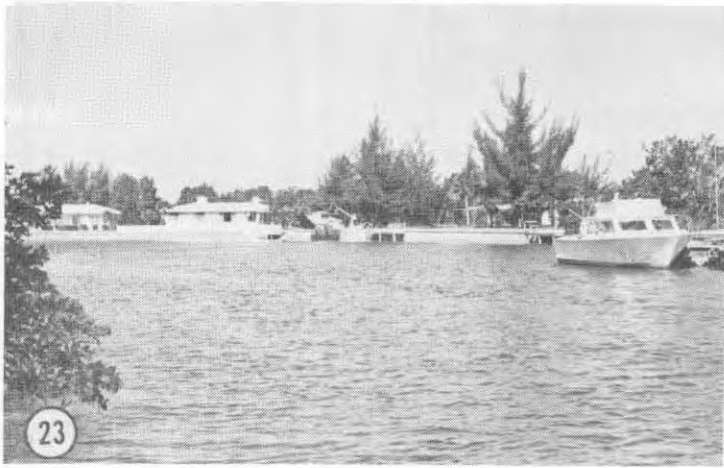
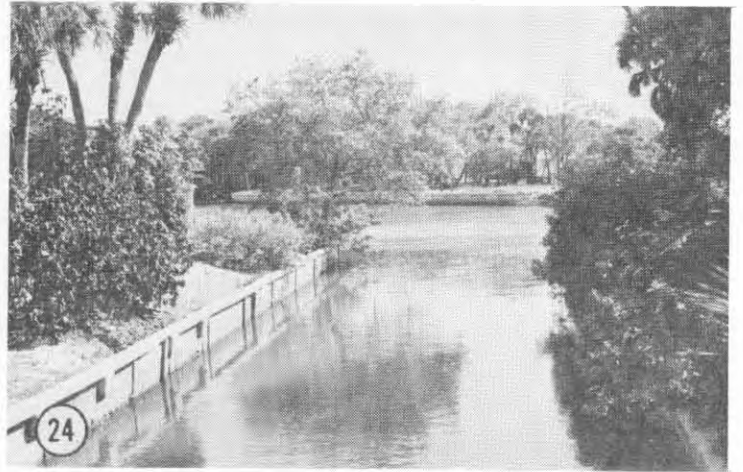
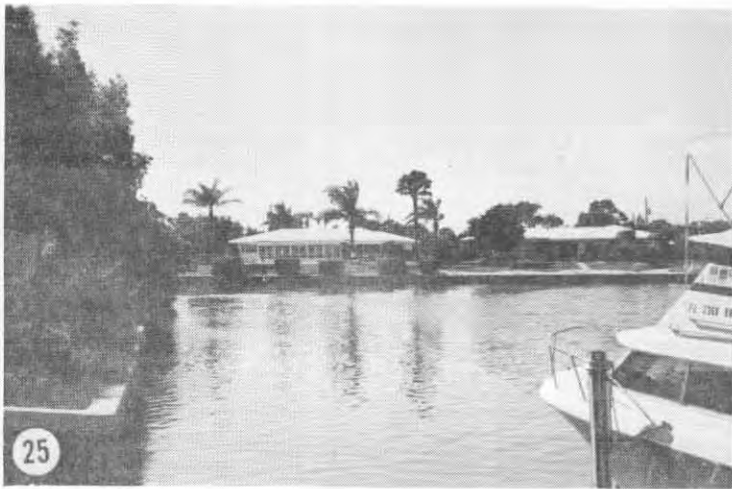
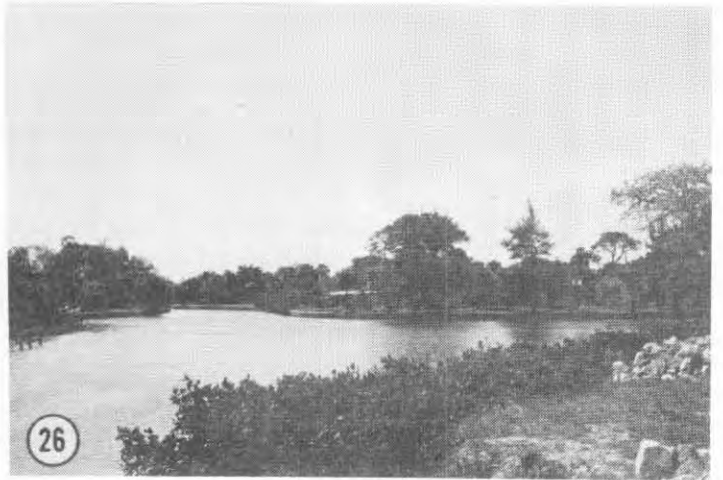
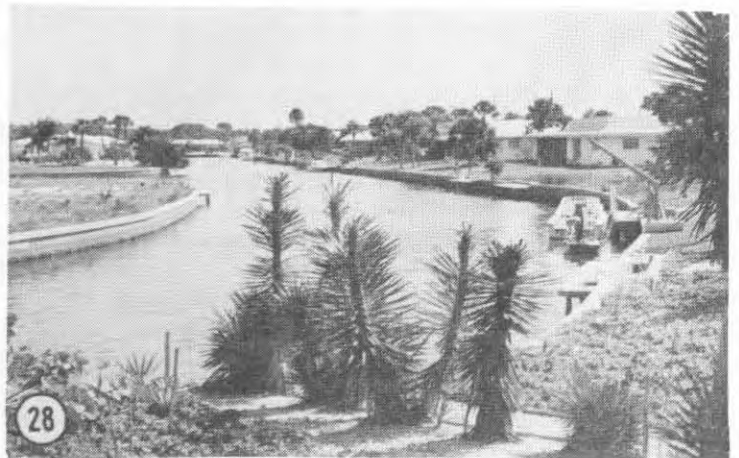
- Figure 23. Grand Canal, area of Station 1 near entrance to Grand Canal.
- Figure 24. View from Higel Avenue bridge of Station 4 at the junction of the side canal and Grand Canal in the background.
- Figure 25. Grand Canal at Station 15. The sea wall at the left is the edge of SKUA property. Barely visible in the upper left area of the waterway is a mass of white foam near the SKUA outfall.
- Figure 26. View of Palm Island area. Station 10. In the foreground is a pruned hedge of white mangroves along the non-seawalled shore of the Avenue del Norte Parkway.
- Figure 27. Palm Island Waterway. Adjacent to Canal Road, Station 9.
- Figure 28. Siesta Isles Waterway in vicinity of Station 14.

Sampling Stations. Figure 22 shows the locations of the eighteen hydrographic stations for the Grand Canal system. Table 4 describes the location of the stations. Dawn and dusk sampling for chemical analysis were limited to Stations 1, 4, 15, 10, 9, and 14 which were located along the Grand Canal between the entrance (Sta. 1), SKUA (Sta. 15), Palm Island (10, 9) and Siesta Isles (14). Figures 23-28 show views of the Canal at these hydrographic stations. The hydrographic stations in the Heron Lagoon system (Fig. 29, Table 5) were selected mainly on their accessibility from nearby roads. Again dawn and dusk samples for chemical analysis were taken at all stations except Stations 2 and 5. Figures 30-35 show views of the Heron Lagoon Waterways at several hydrographic stations.

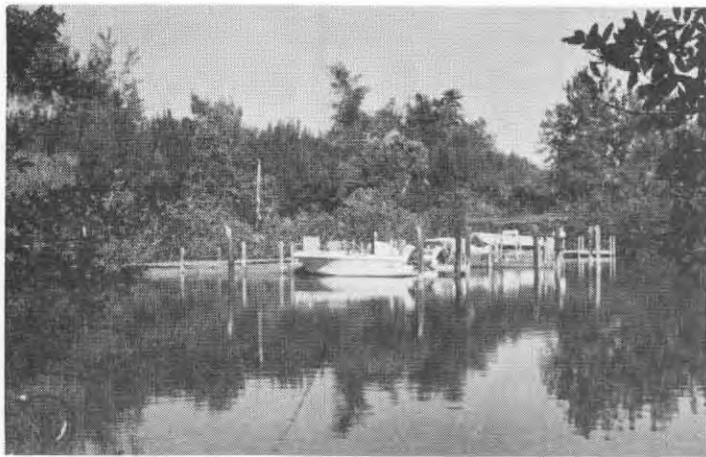
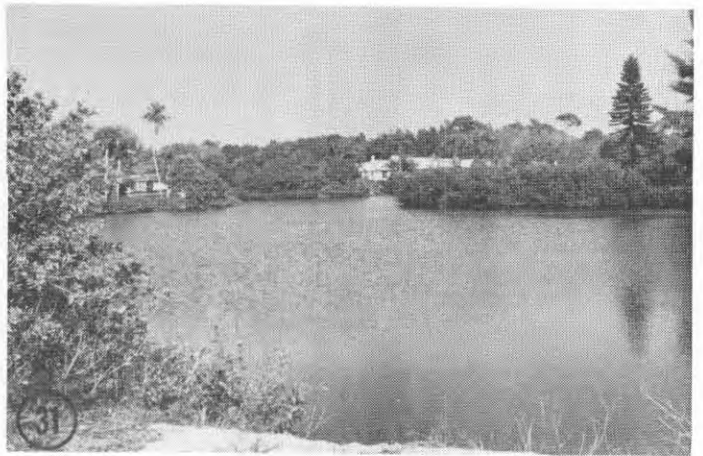
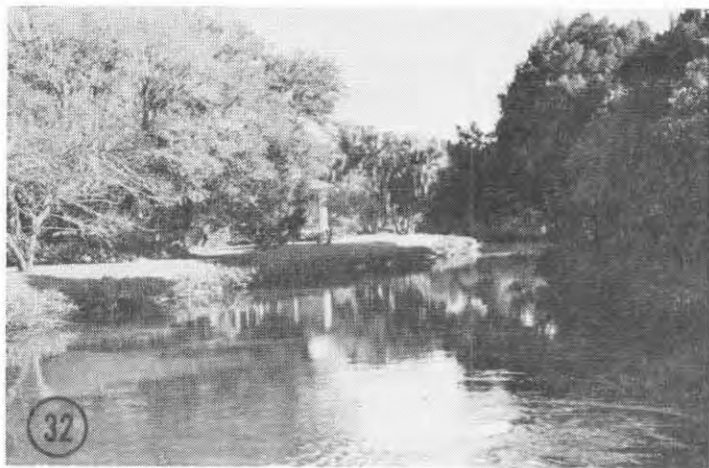
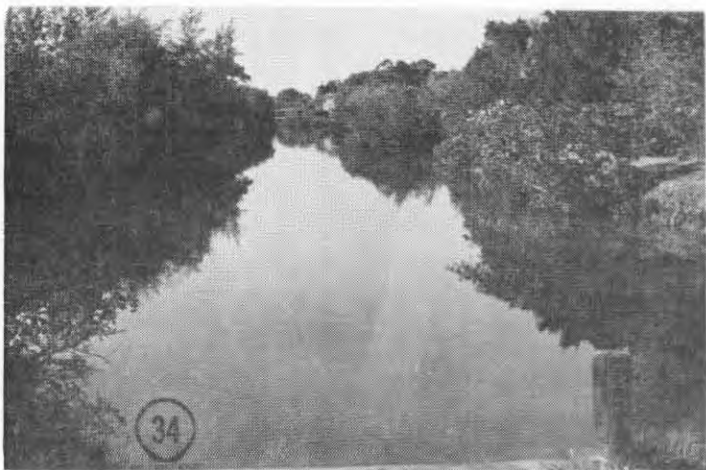
Figure 34. Heron Lagoon, Mid Waterway. Station 3, looking north.

Figure 35. Heron Lagoon, Mid Waterway, Station 3, looking south toward Heron Lagoon. The Waterway is partially overgrown by Brazilian pepper and mangroves.

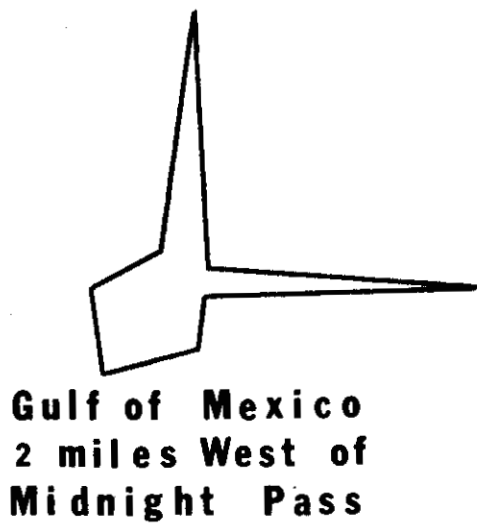
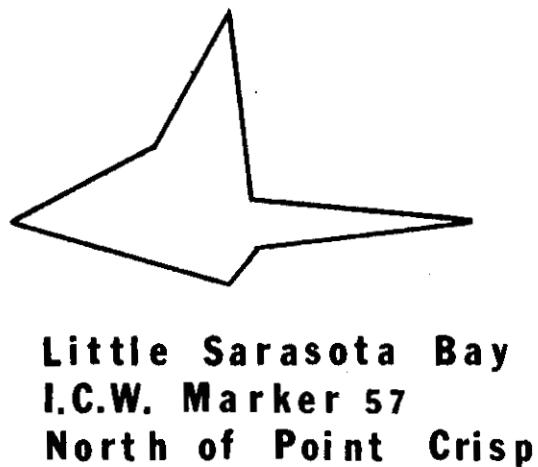
**Figure 47 Polygonal graphs of surface water at four hydrographic stations. See Figure 46 for Key.**
