ALLIGATOR CREEK SEDIMENT MANAGEMENT PLAN FINAL REPORT

Prepared for the:
Sarasota County Water Resources

04 April 2006

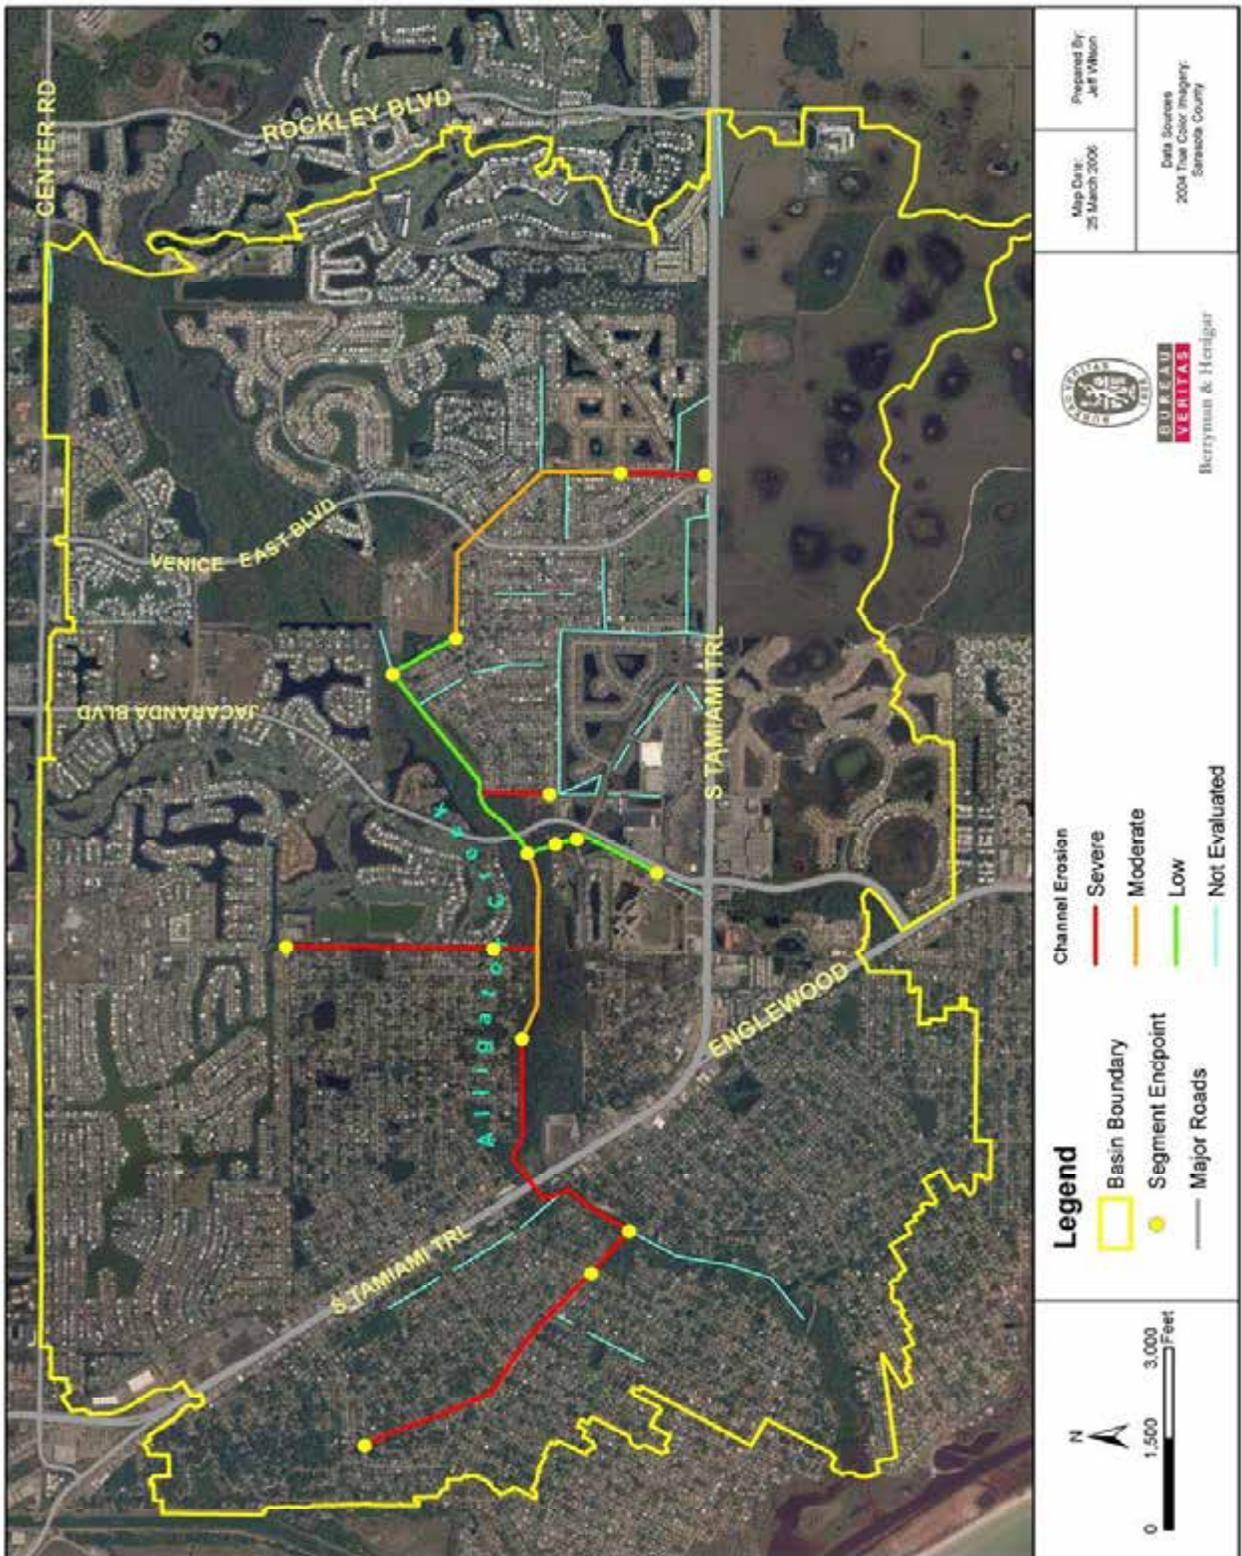
Figure 5. Segment Erosion Map, Alligator Creek Watershed

System conditions during the May-November field investigations indicated varying degrees of erosion along banks of the five tributary areas (Systems 1-5) and Alligator Creek (System 6). Each system was characterized as having *minimal*, *moderate*, or *severe* bank erosion, suggesting minimal, moderate, or severe sediment export potential (respectively) into Alligator Creek. Because the degree of erosion and potential treatment options were variable within most systems, individual sub-system segments were identified and numbered in increasing order from downstream to upstream for convenience (Figure 4). The degree of erosion determined for each segment in the Project Study Area is presented in Figure 5 and further characterized in the following sub-sections.

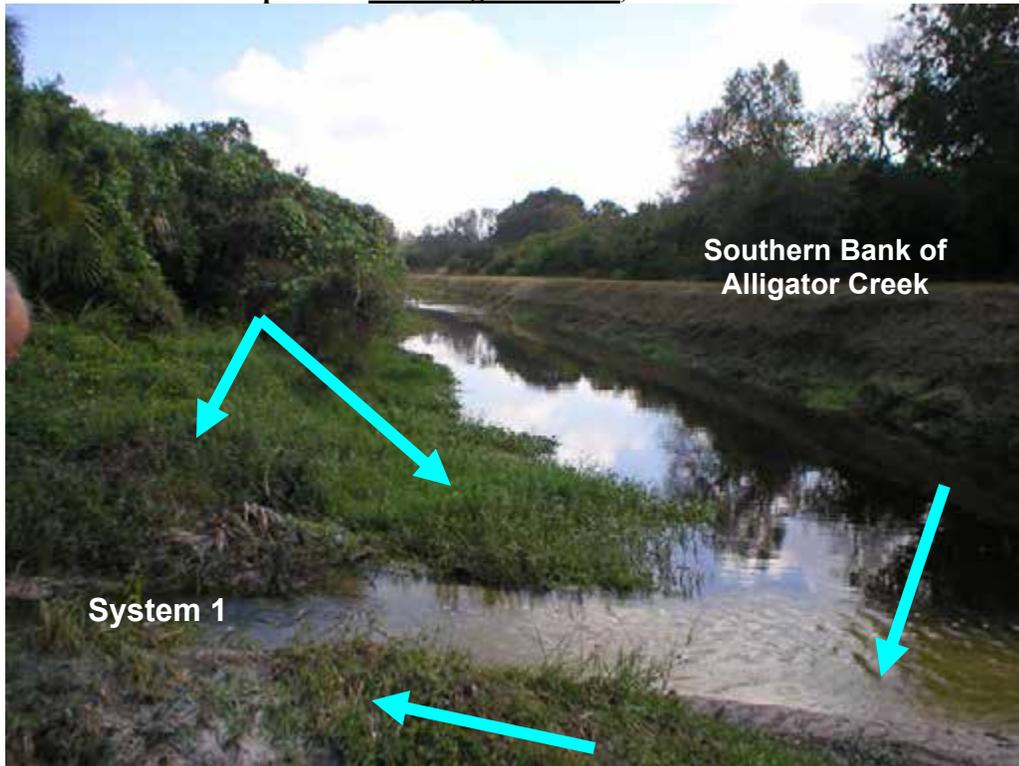
Photo 4 - System 1 - Segment 1
Undercutting of Southern Bank at Alligator Creek, November 2005

Yellow Arrows = undercutting. Aqua Arrows = sediment deposition

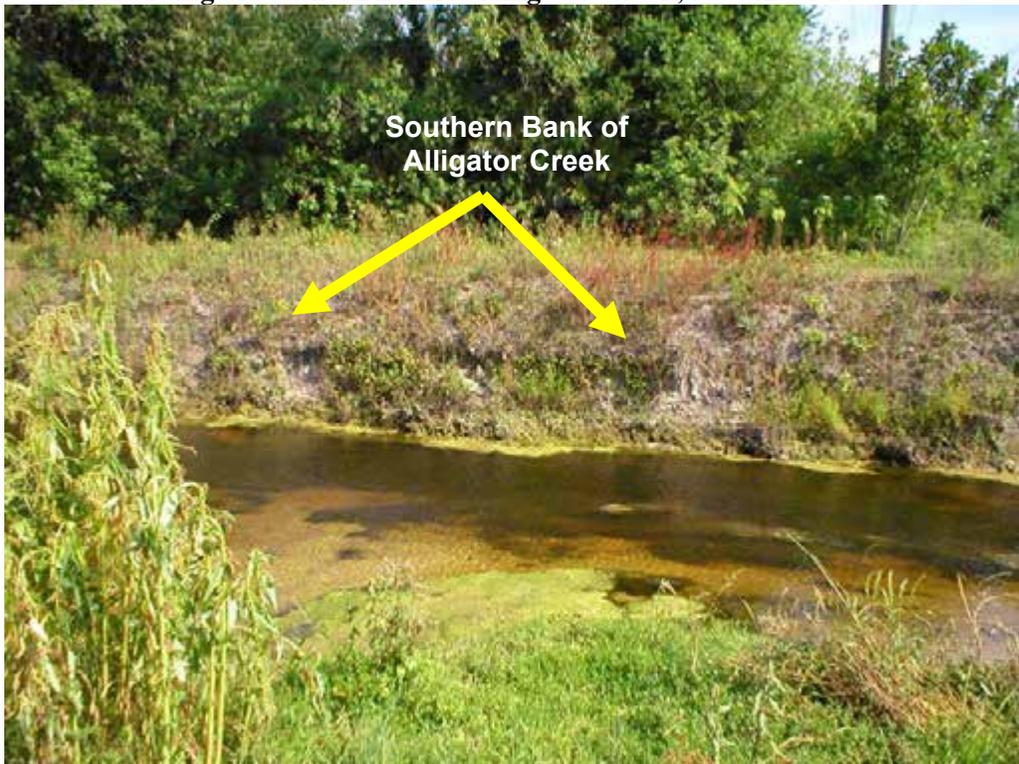
Photo 5 - System 2 - Segment 3
Aquatic Vegetation , May 2005

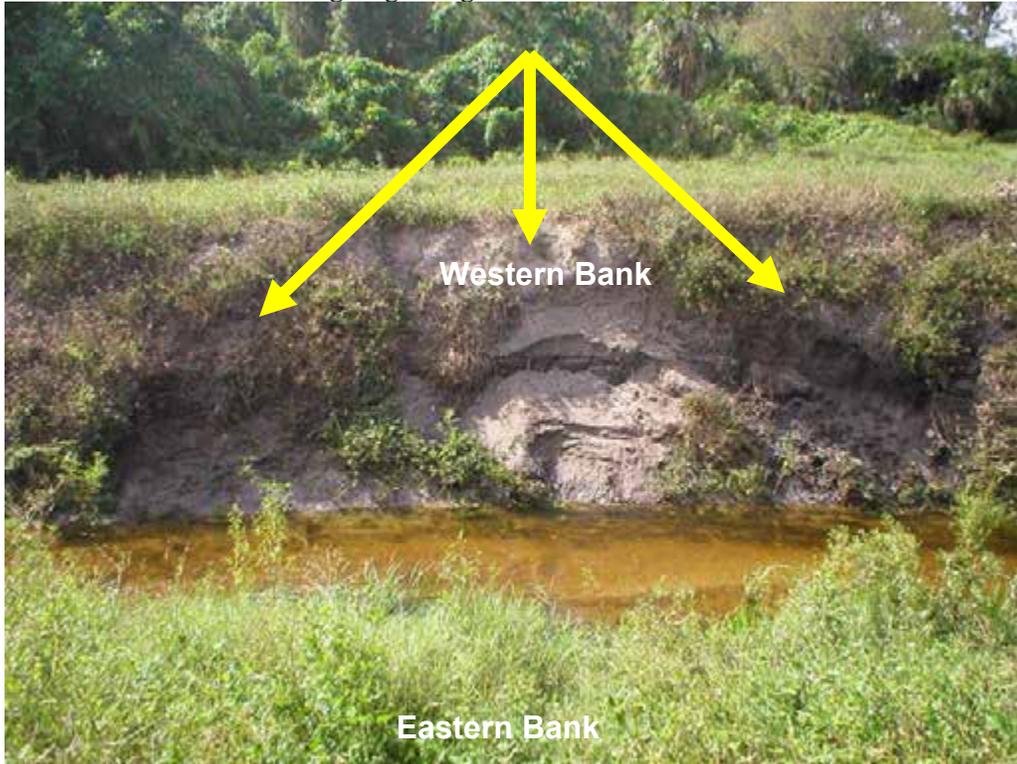
Photo 12 - System 3
Erosion along Eastern and Western Banks, May 2005

Yellow Arrows = sloughing. Aqua Arrows = sediment deposition

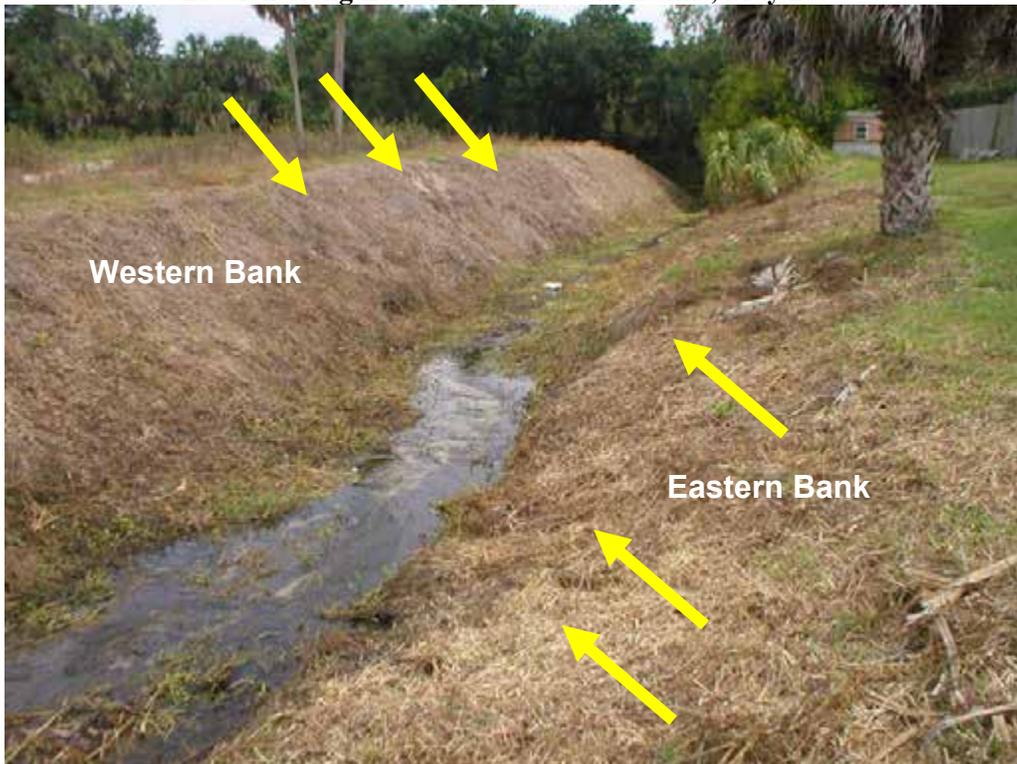
Photo 13 - System 3
Sediment Deposition into Alligator Creek, May 2005

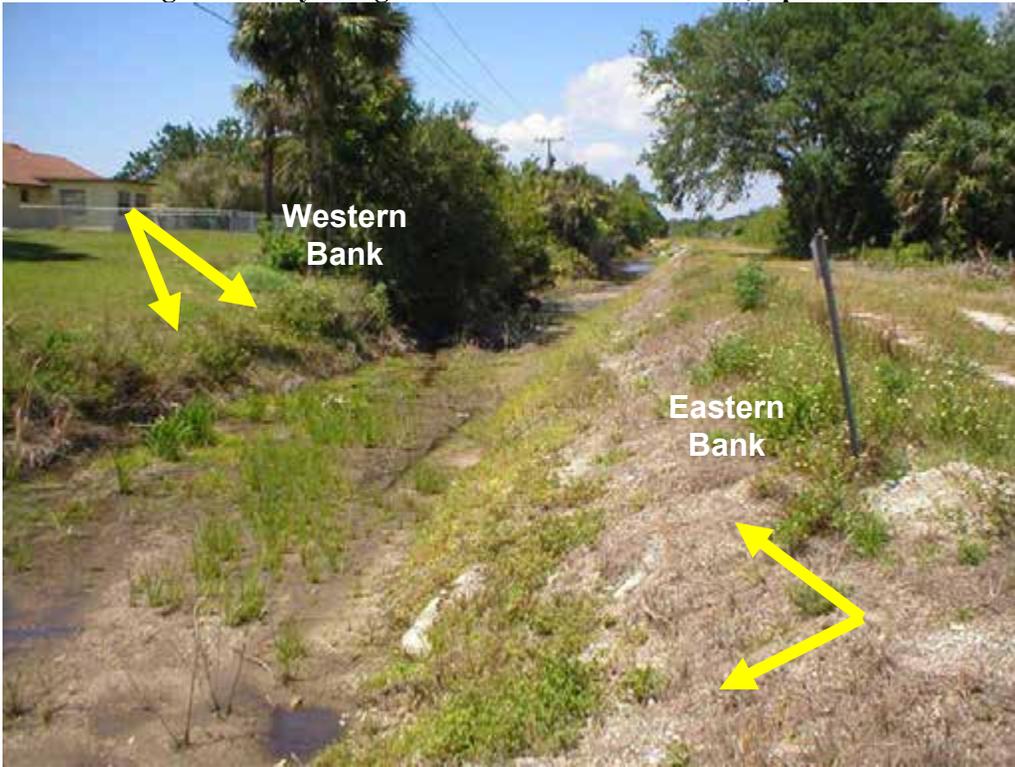
Photo 16 - System 4 – Unevaluated Reach East of Segment 2
Highly Eroded Banks with Variable Vegetative Cover, April 2005

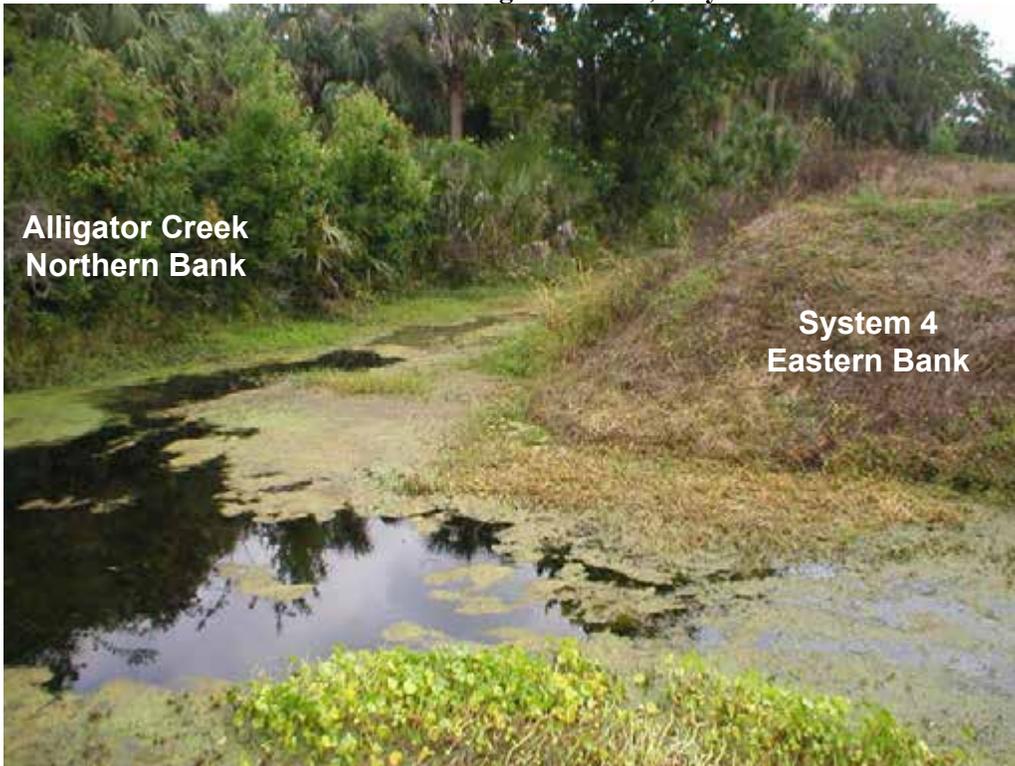
This three-segment system begins at South Tamiami Trail just east of Venice East Boulevard and discharges north into Alligator Creek near the County Water Treatment Plant. The 3rd (upstream) segment, which ends at Paddington Street, is characterized by steep, sandy, sparsely vegetated slopes. Sloughing and sediment deposition were noted in multiple locations along this highly eroded segment (Photos 15 and 16). The 2nd segment occurs between Paddington Street and Dorchester Road. Banks along this segment were also steep and sandy, but vegetative cover was variable, and previously installed stabilization materials were observed in some locations (Photo 17). Erosion was considered moderate in this segment. The 1st (downstream) segment begins at Dorchester Road, traverses the western edge of the County water treatment plant, and discharges north into Alligator Creek (System 6). This segment was characterized by steep, grassy slopes and a slightly nutrient-rich aquatic environment (Photos 18 and 19). Although erosion within this segment was relatively minimal, undercutting along the northern bank of Alligator Creek and sediment deposition along the southern bank were noted during the May-November field events (Photo 20).

Photo 20 – System 4 - Segment 1
Sediment Deposition (Vegetated) Intersection with Alligator Creek, May 2005

Aqua Arrows = sediment deposition

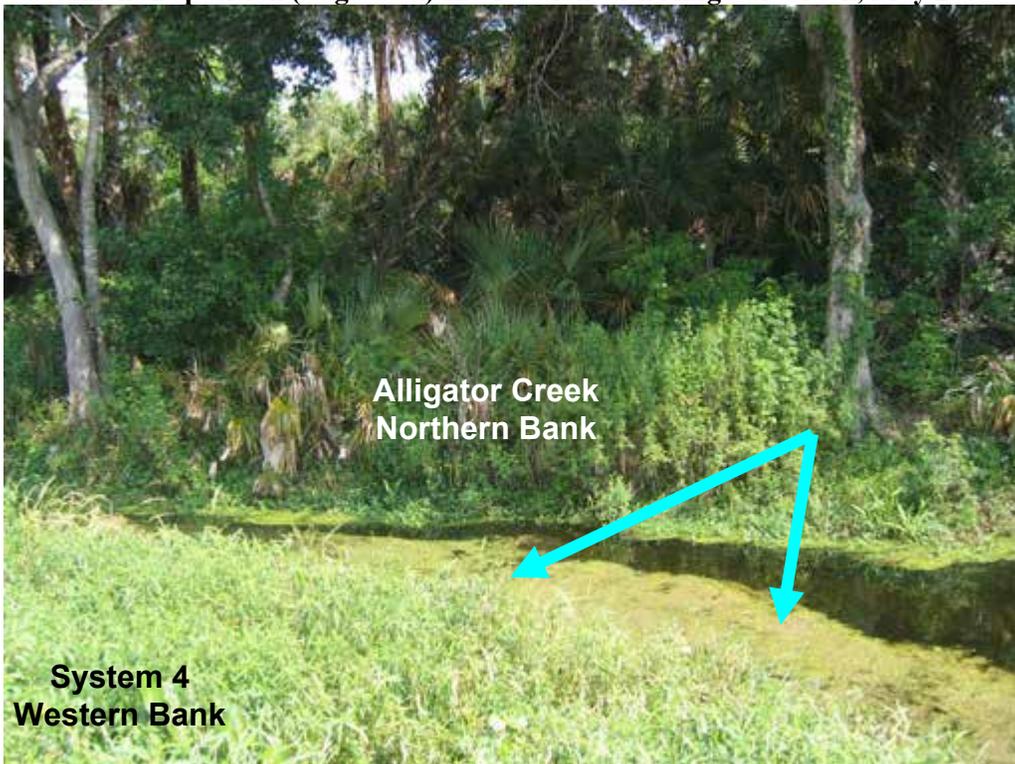
sediment deposition along the ditch bottom were noted during the May-November field events (Photos 21 and 22). County personnel indicated that the sloughing of the banks resulted from direct stormwater runoff from Siesta Drive, and that ditch armoring was installed in some areas to prevent future sloughing (personal communication with Sam Heyes, July 27, 2005). An investigation of these armored areas revealed no sloughing. The 1st (downstream) segment extends south from a 9 foot by 14 foot culvert beneath Baffin Road to Alligator Creek (Photo 23). Side slopes were steep and densely vegetated in this segment and sloughing was severe along both banks, with considerable sediment deposition noted along the stream channel bottom (Photos 24 and 25).

Photo 21 - System 5 - Segment 2
Sloughing Slopes and Sediment Deposition along Western Bank, May 2005

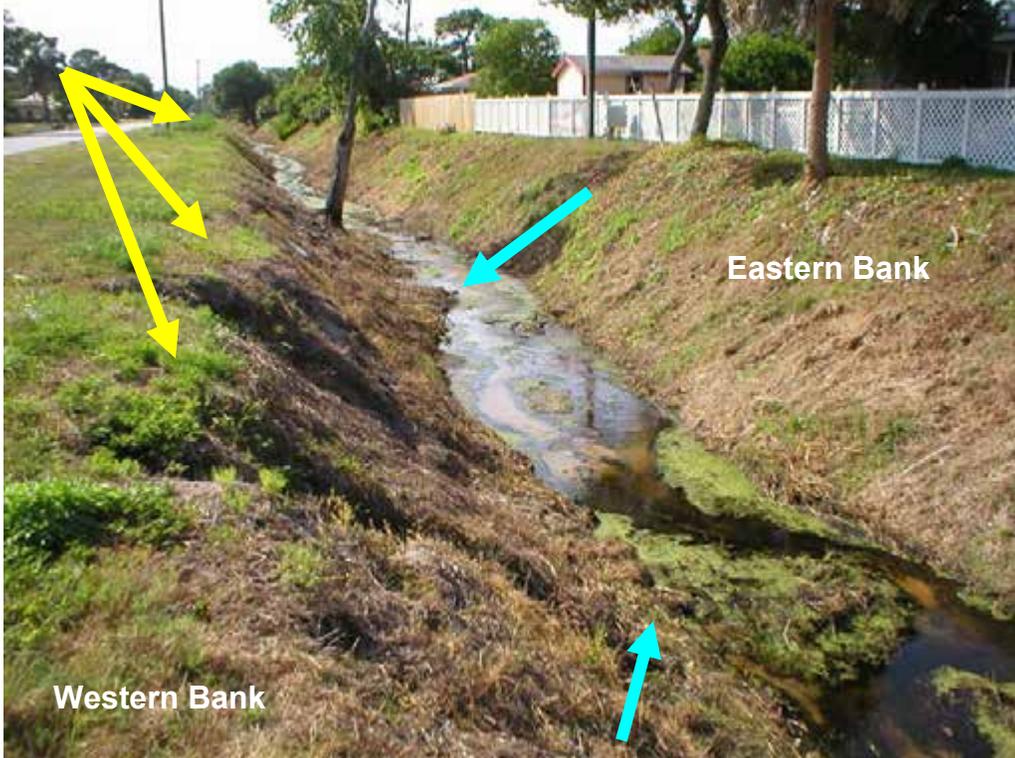
Photo 22 – System 5 - Segment 2
Severely Sloughing Slopes along Western Bank, May 2005

Yellow Arrows = sloughing. Aqua Arrows = sediment deposition

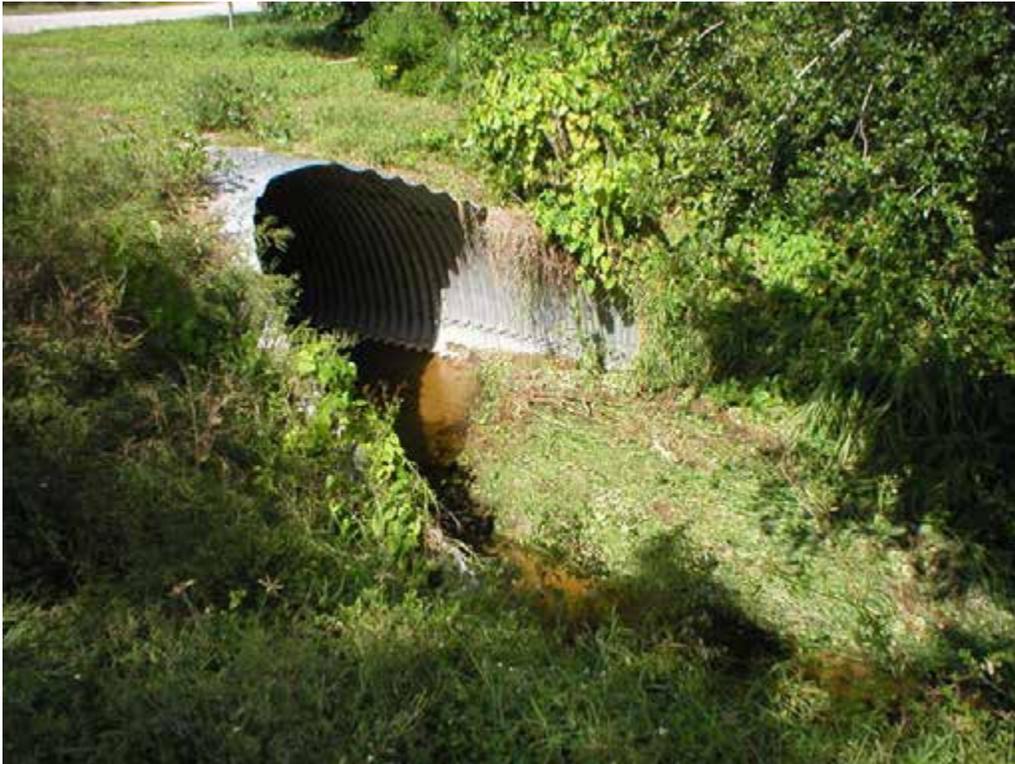
Photo 24 – System 5 - Segment 1
Severely Sloughing Slopes and Sediment Deposition, May 2005

Yellow Arrows = sloughing. Aqua Arrows = sediment deposition

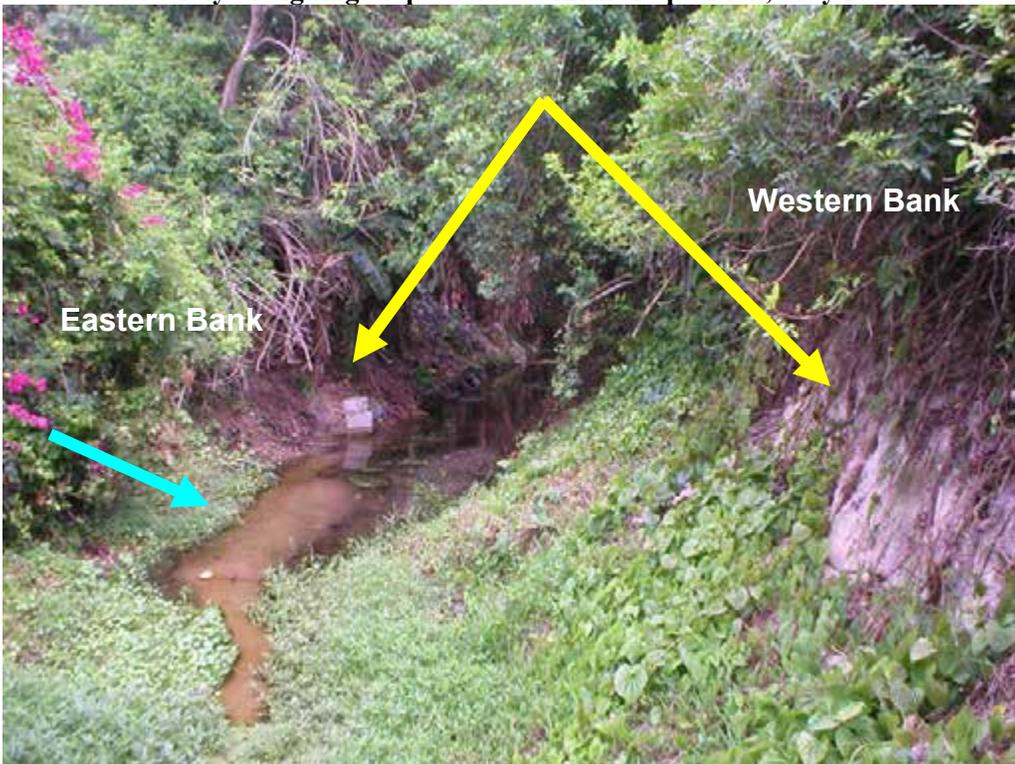
Photo 25 - System 6 - Segment 3
Steep, Sandy Southern Bank, April 2005

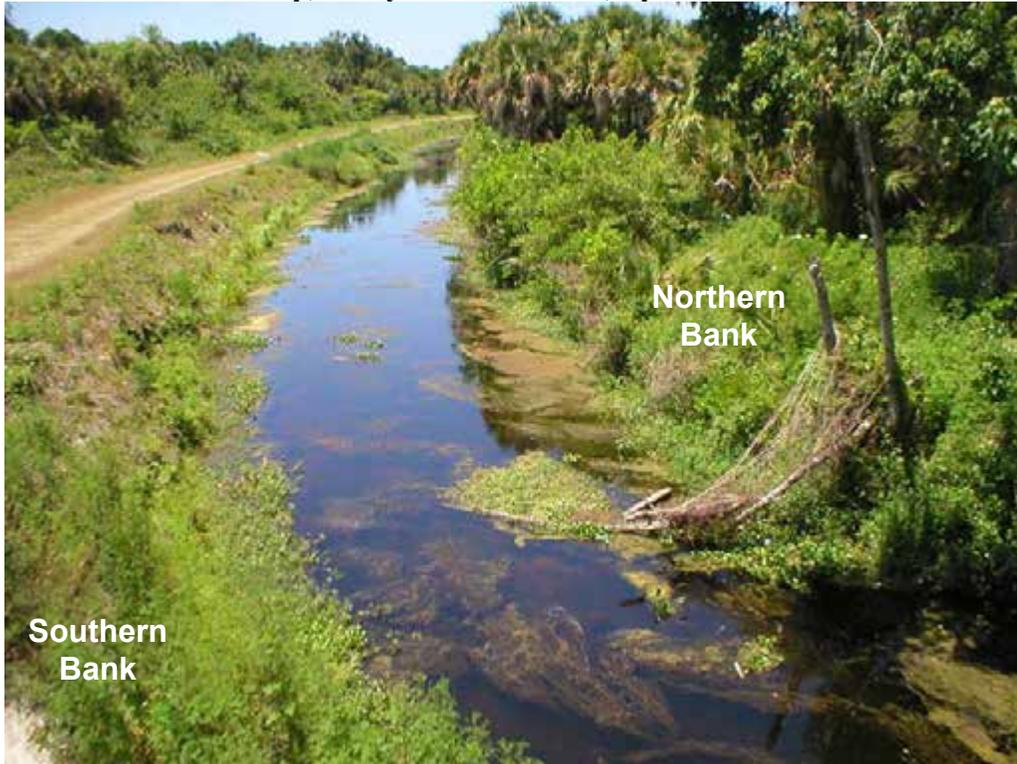
Photo 26 - System 6 - Segment 3
Undercutting of Northern Bank and Sediment Deposition from System 3, July 2005

Yellow Arrows = undercutting. Aqua Arrows = sediment deposition

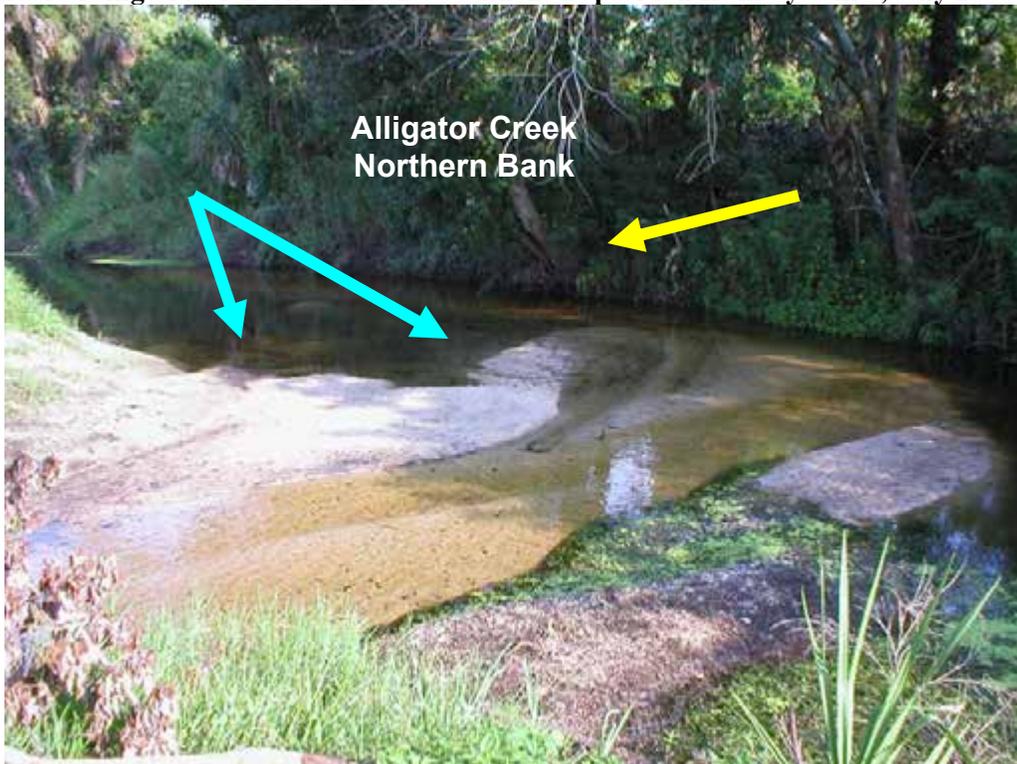
Photo 27 – System 6 - Segment 3
Undercutting of Banks from System 4, May 2005

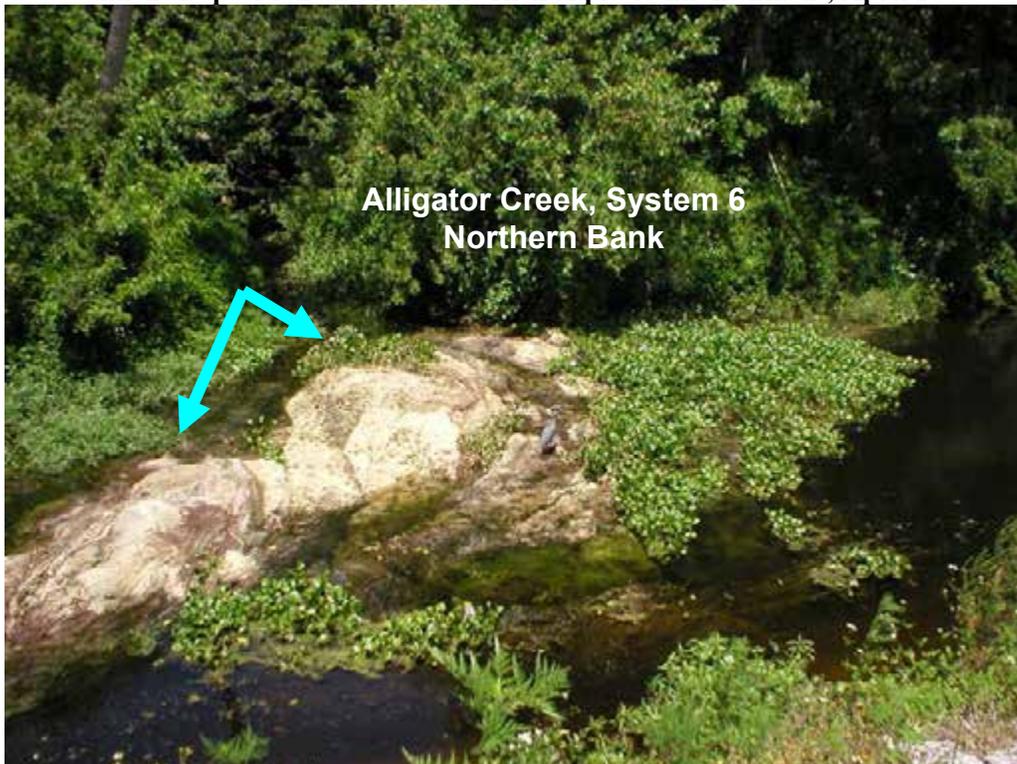
Photo 29 – System 6 - Segment 2
Sloughing along Southern Bank, November 2005

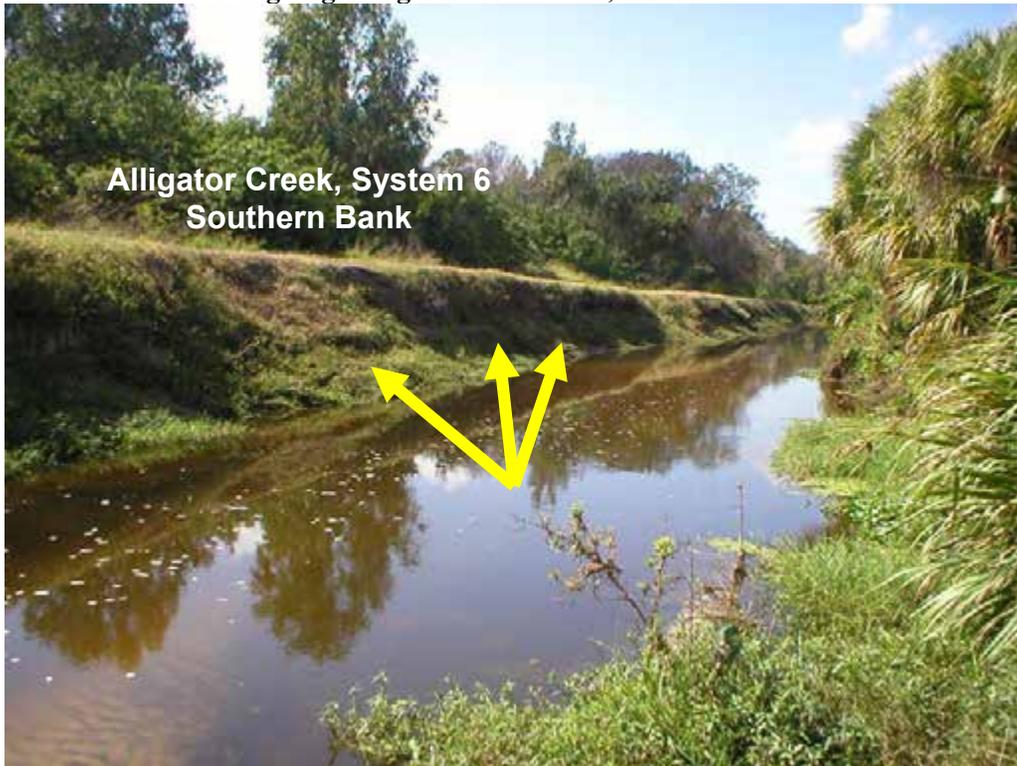
Photo 30 – System 6 - Segment 2
Washout of Banks from System 2, October 2005

Yellow Arrows = sloughing. Red Arrows = washout

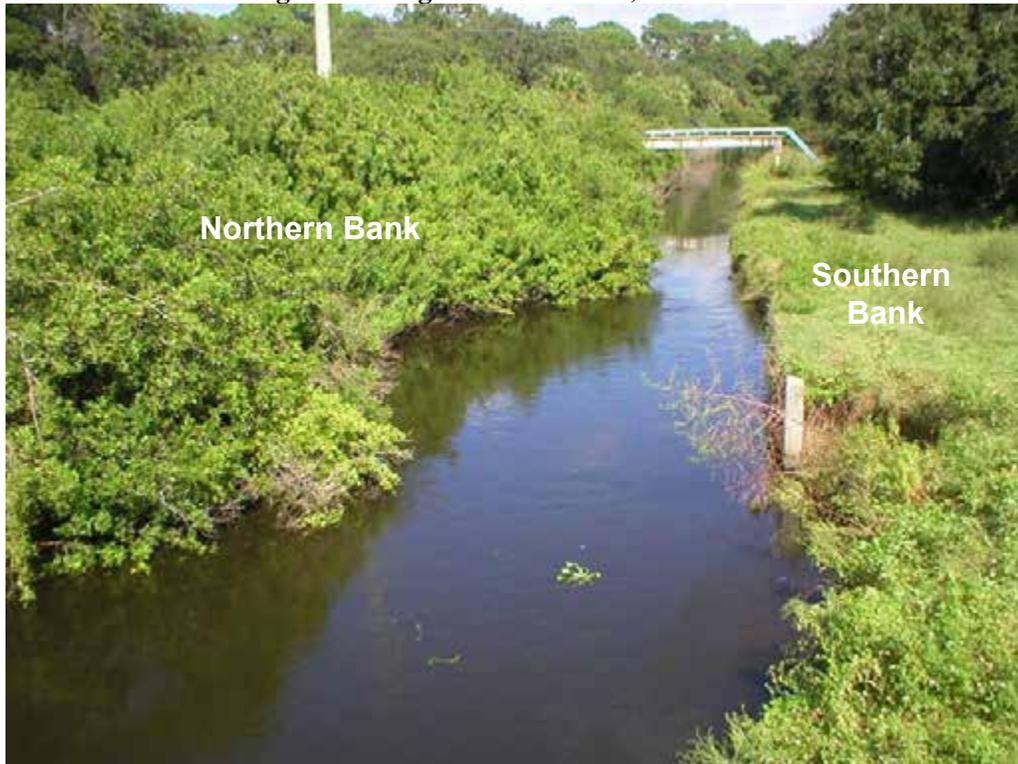
The 1st segment, defined by brackish water chemistry and a northern bank lined by mangroves and Brazilian pepper trees (many dead), ends just west of US41 at System 5 (Photos 31 and 32). Erosion in this segment was severe and occurred primarily along the southern bank where slopes remained steep, sandy, and sparsely vegetated (Photo 33). Also noted was an area west of System 1, where surface water from a wetland just south of the Creek breached its bank and flowed into the Creek, washing away the top of the Creek bank in the process (Photo 34).

Photo 32 – System 6 - Segment 1
Steep, Sandy, Sparsely Vegetated Southern Bank
with Dead Brazilian Pepper at Northern Bank, November 2005

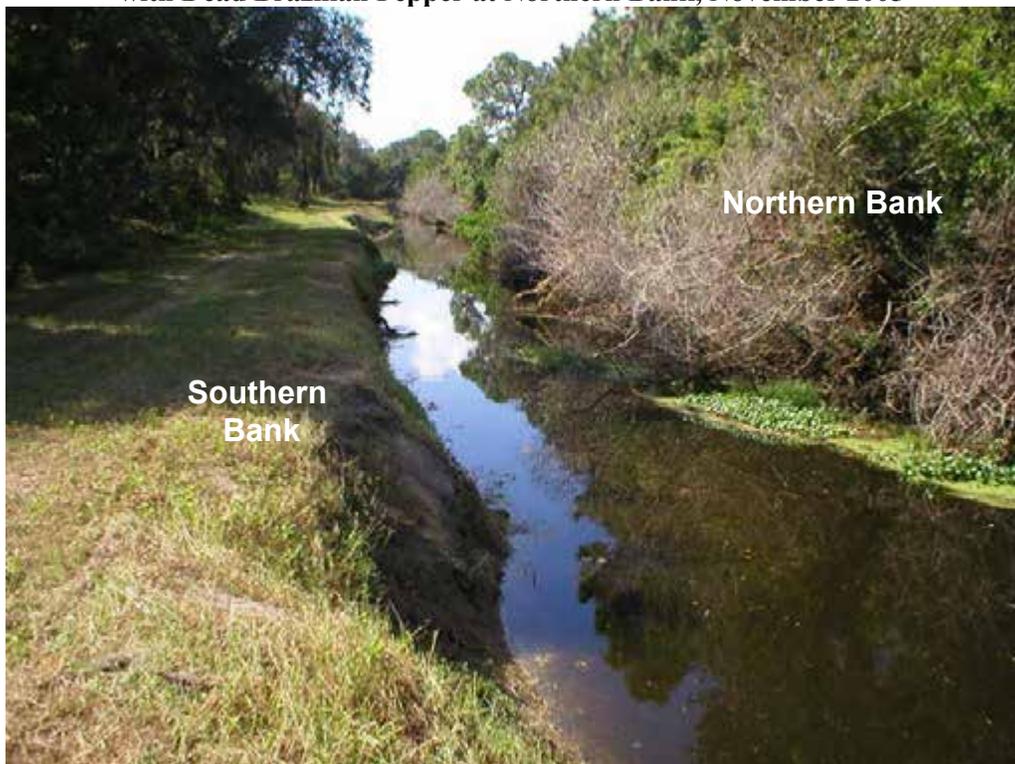
Photo 33 – System 6 - Segment 1
Soughing along Southern Bank, November 2005

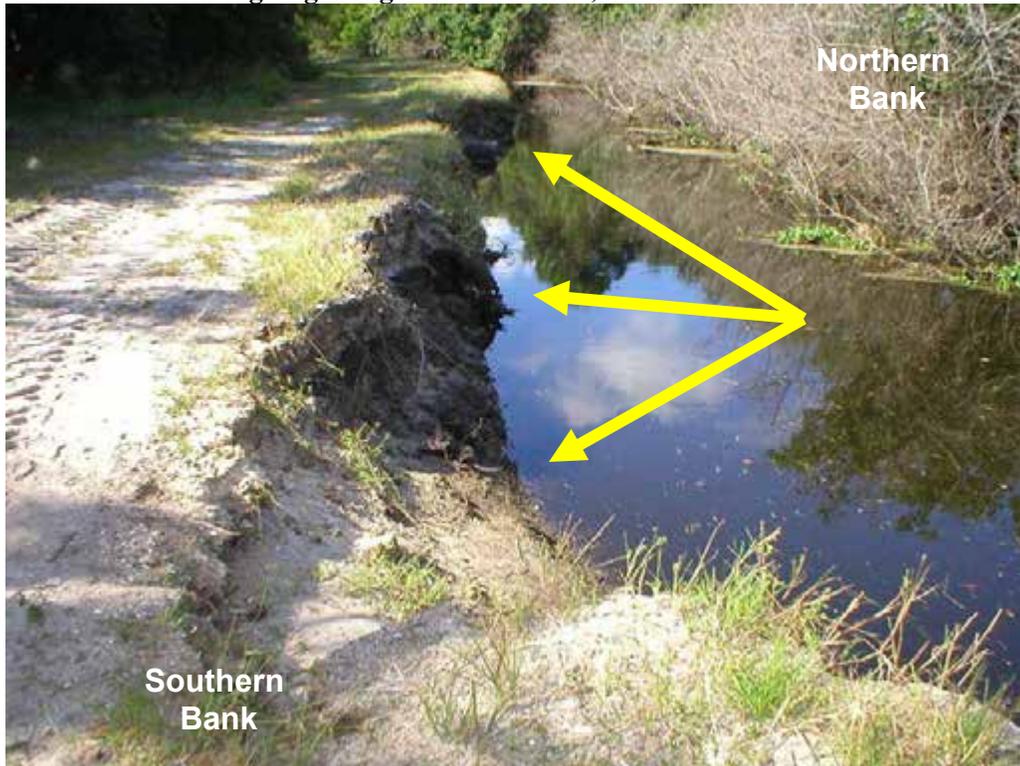
Photo 34 – System 6 - Segment 1
Washout of Southern Bank from Wetland to South, November 2005

Yellow Arrows = sloughing. Red Arrows = washout
