**Peace River Hydrobiological
Monitoring Program
2007 HBMP Annual Data Report**

**Southwest Florida Water Management District
Water Use Permit 20010420.0004**

**Peace River Manasota Regional
Water Supply Authority**

May 2008

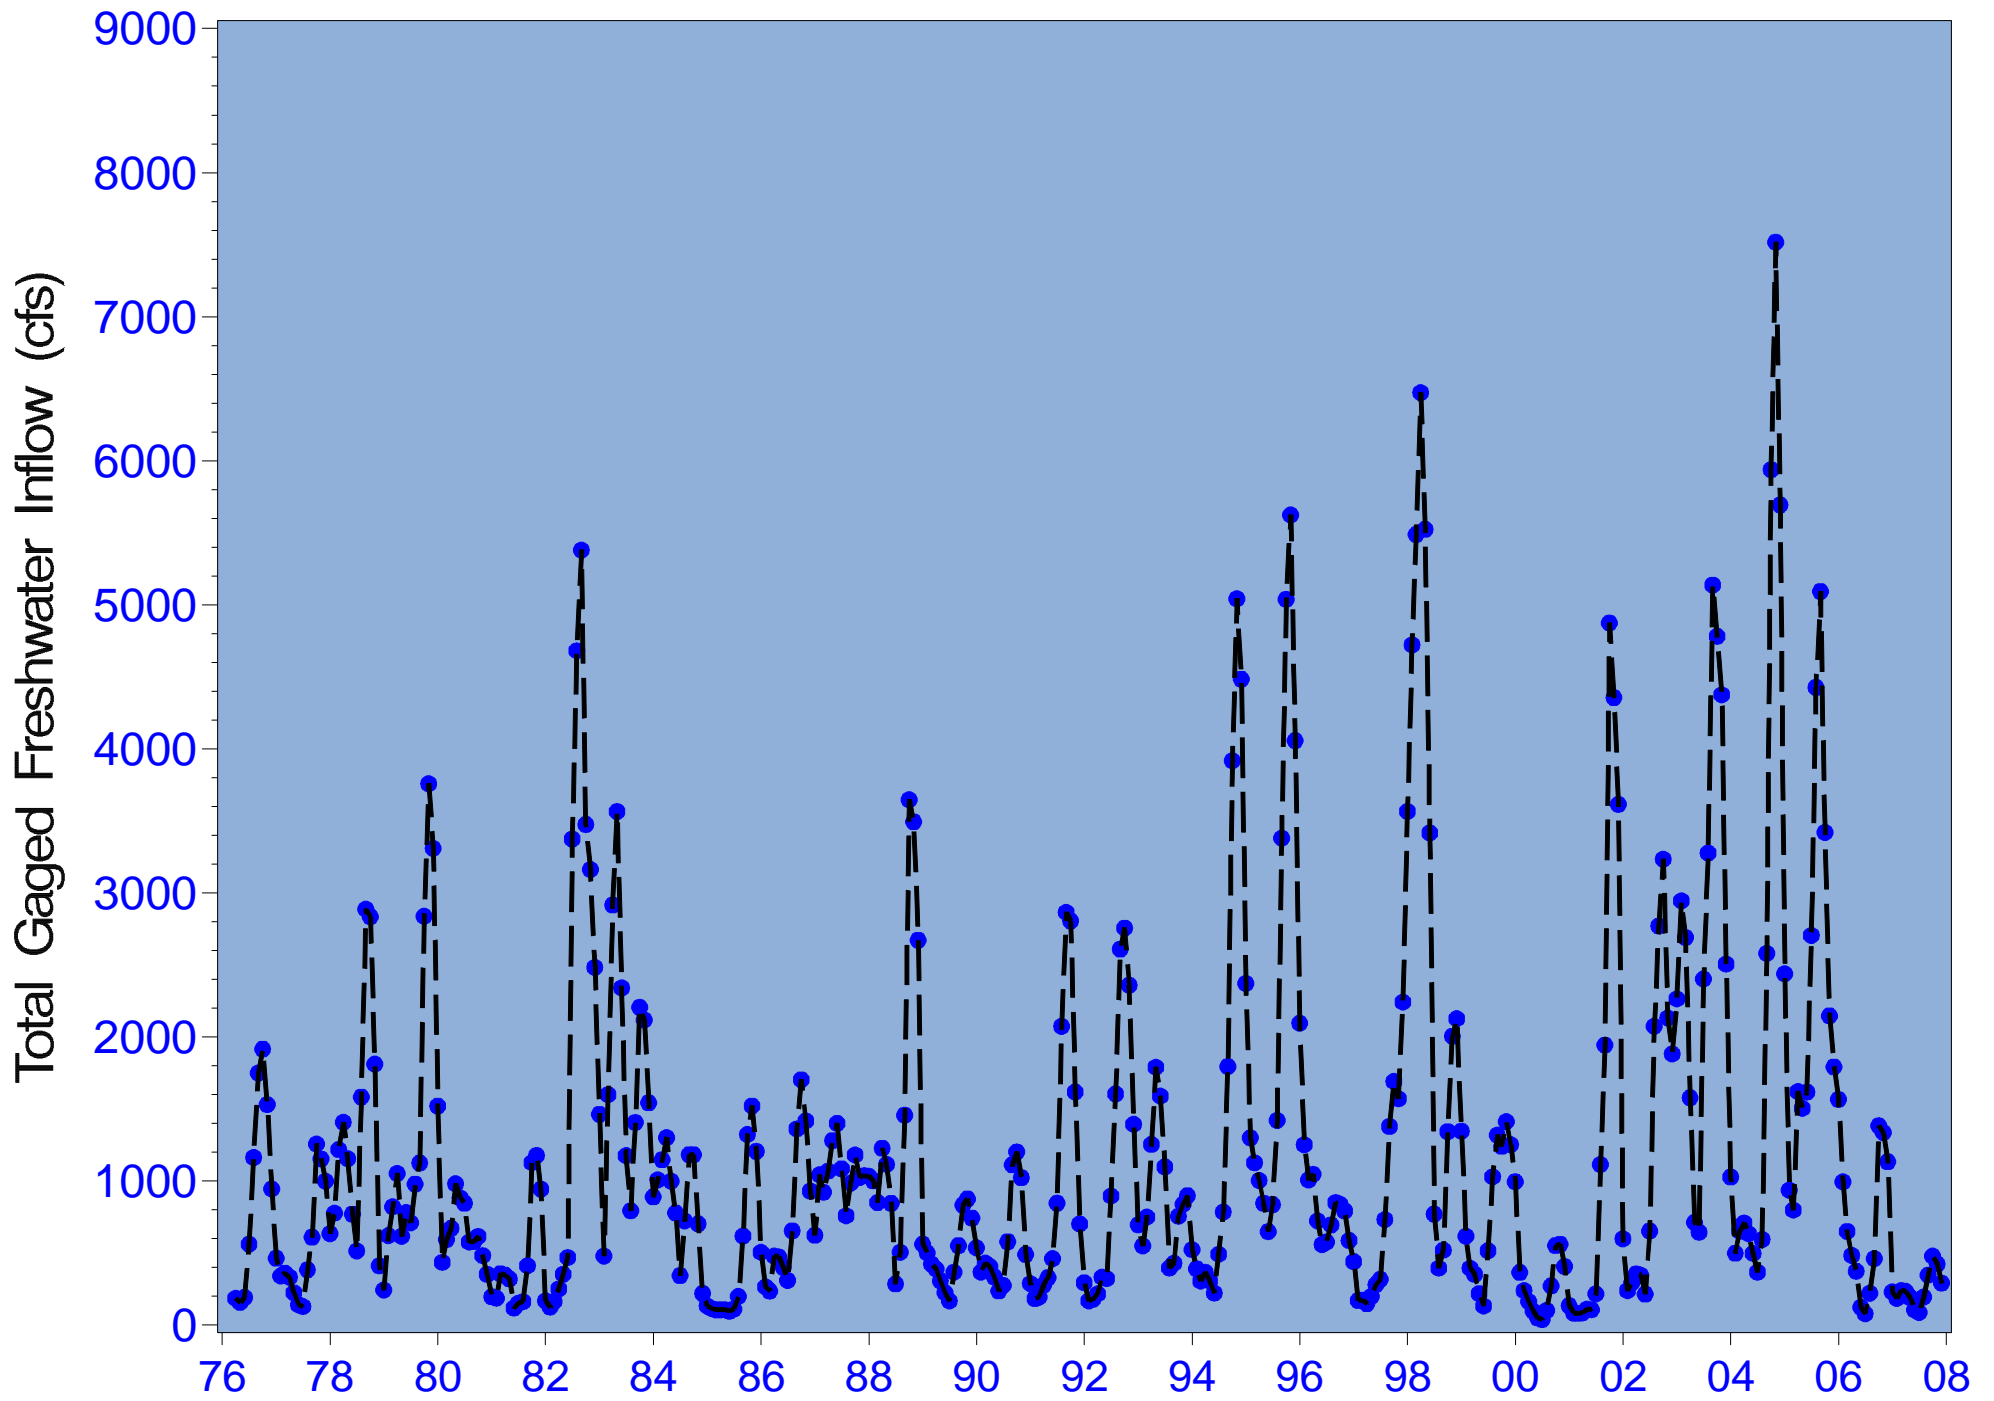
Figure 2.9 3-Month moving average flow - Peace River + Horse and Joshua Creeks (1976-2007)

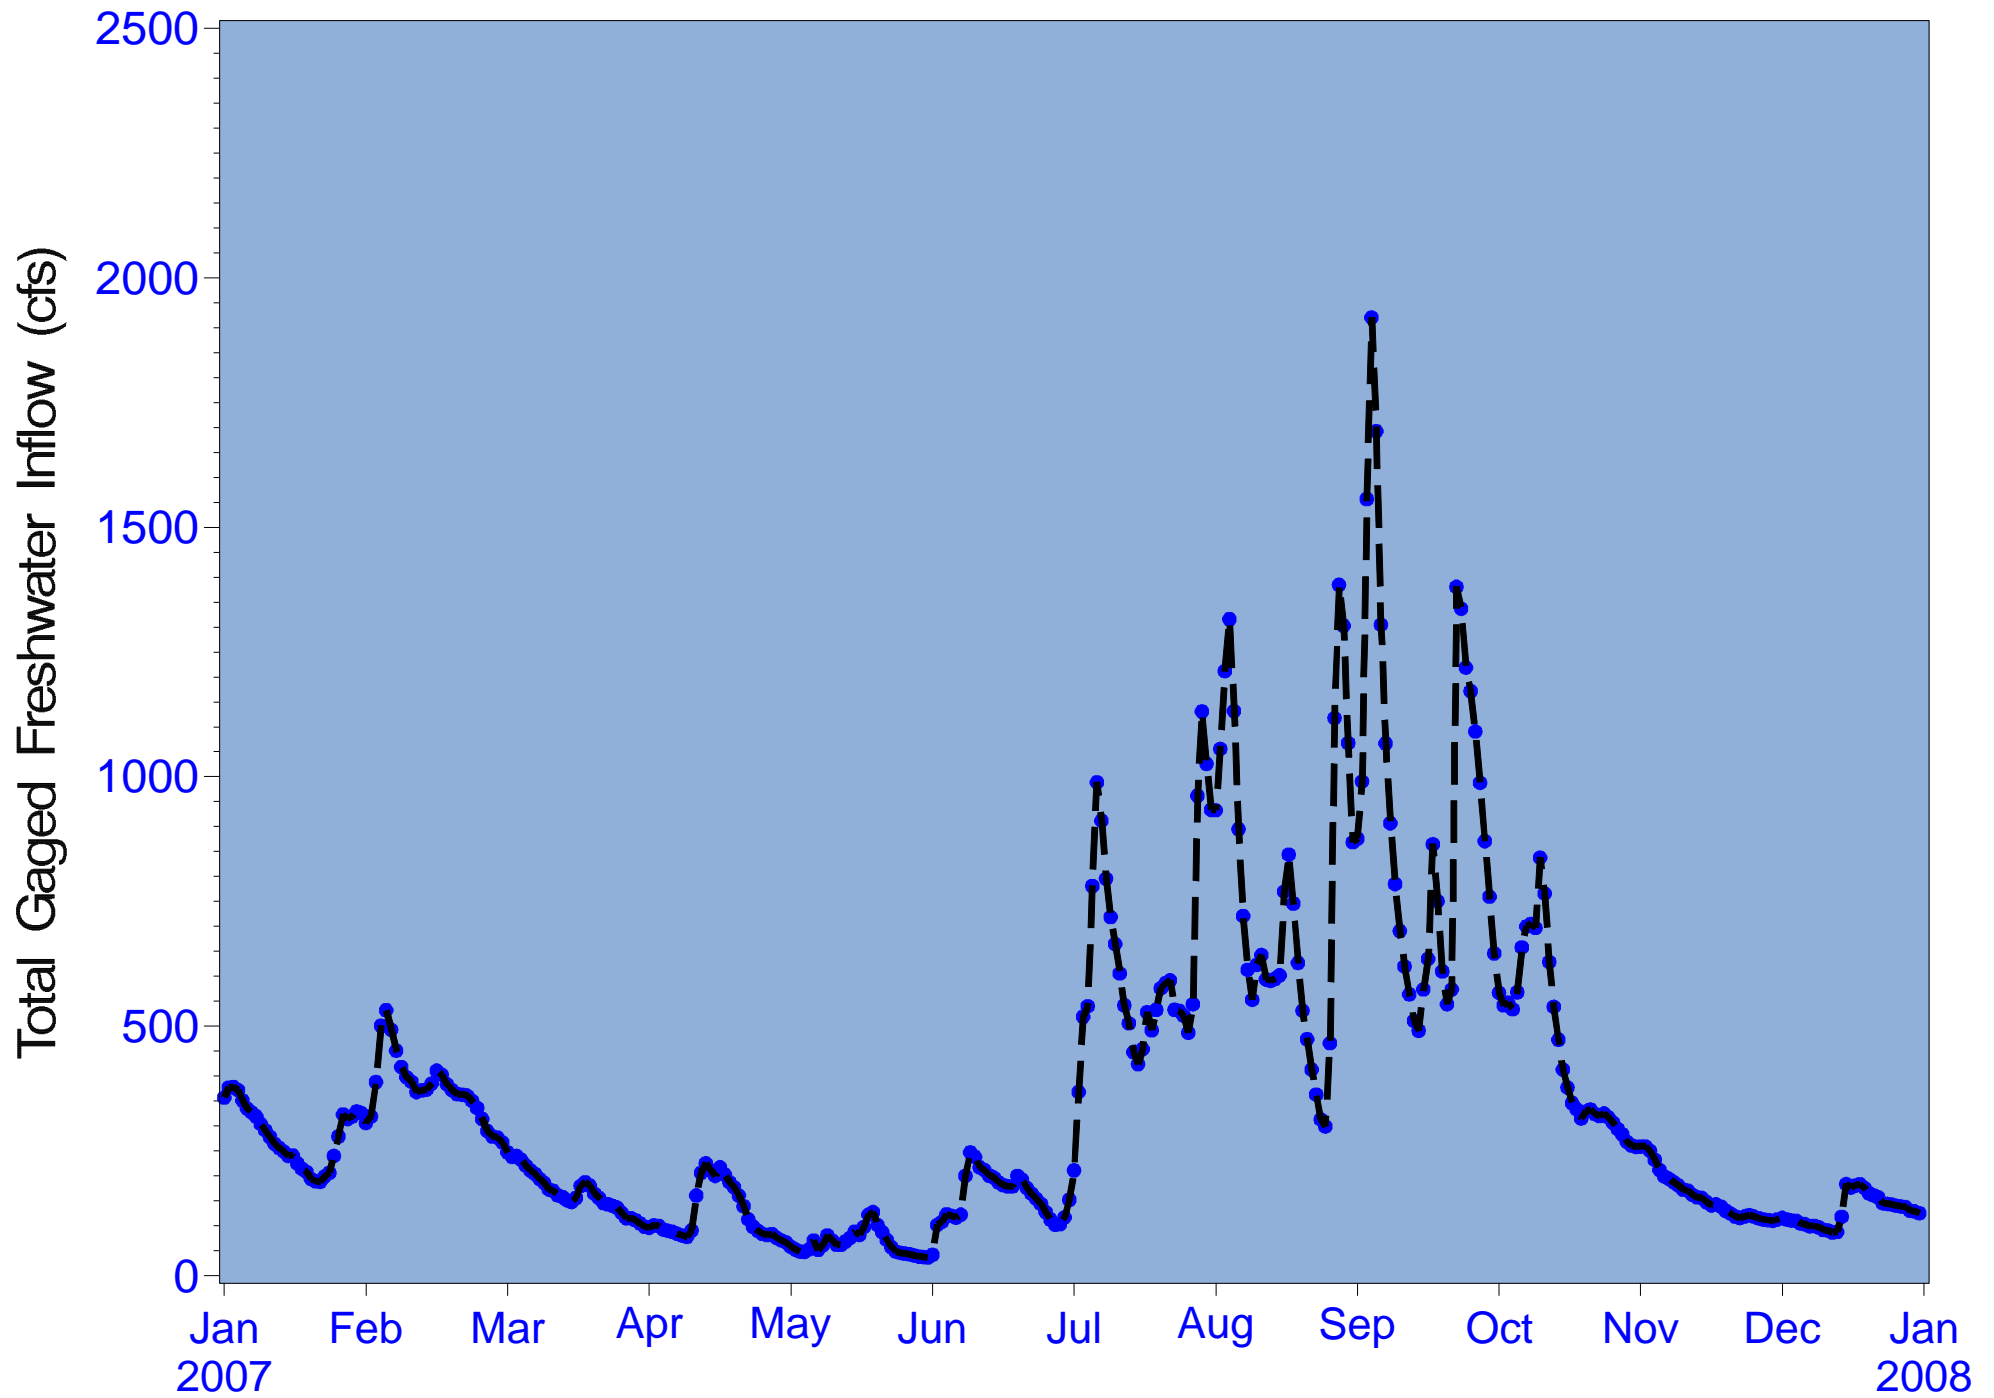
Figure 2.10 Total daily gaged flow - Peace River at Arcadia + Horse, Joshua and Shell Creeks (2007)
