# **Sample collection in Warm Mineral Springs**

On November 29, 2012 a group composed of members of Natural Systems and Integrated Water Resources went to Warm Mineral Springs to collect water samples for analysis of Phthalates.

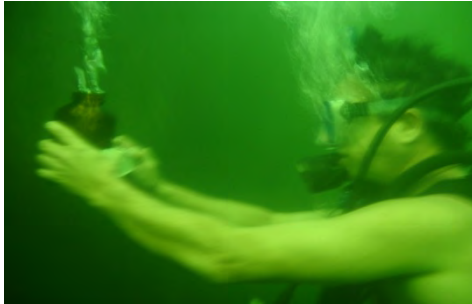
8:40 Second sample or mid depth was collected at a depth of 20 feet (Figure 1)

Figure 1: Samples collected at the 20 feet mark

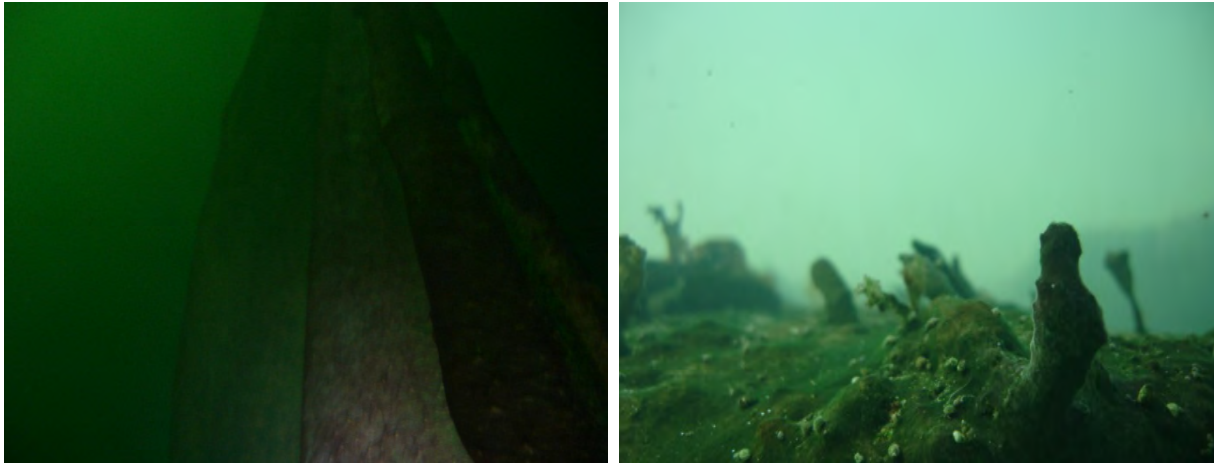
At the 45 foot ledge of the system the ridge was covered with a reddish pink film, biological in origin, (Fig 2 and 3) which makes it appear like the bottom is covered with a blackish tarp (Figs 4 and 5). The substrate underneath the pink film was mucky with some sand.

**Figures 2 & 3: Photographs showing bio-film on top of the liner and bio-film close up.**

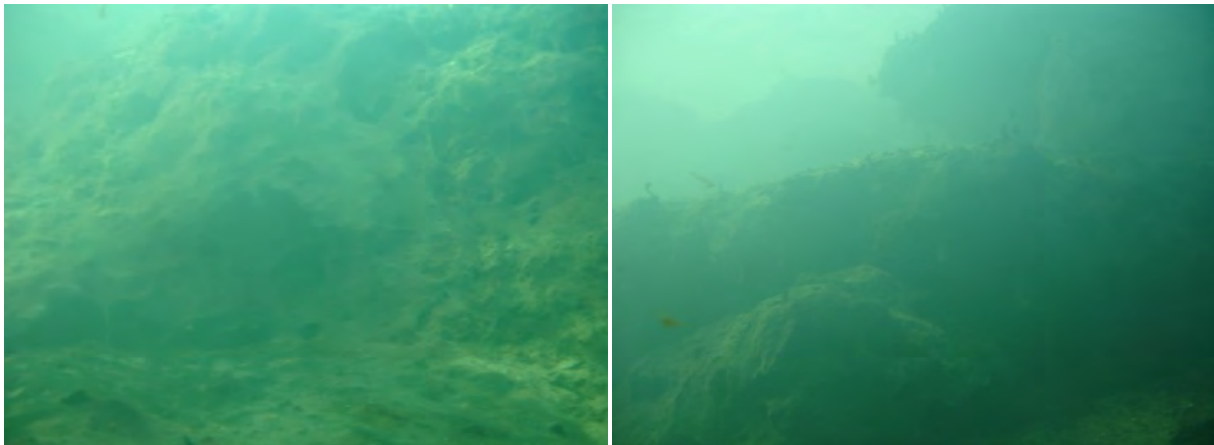
**Figures 4 & 5: Photographs showing the “bio-film” covering all surfaces at 45 feet**

A heavy mill plastic cover is on this ledge. The area of coverage was around 5 to 10% of the whole area, this was covering the “fossil deposits”, and was surrounded by rock outcroppings that were not covered by any sheeting.

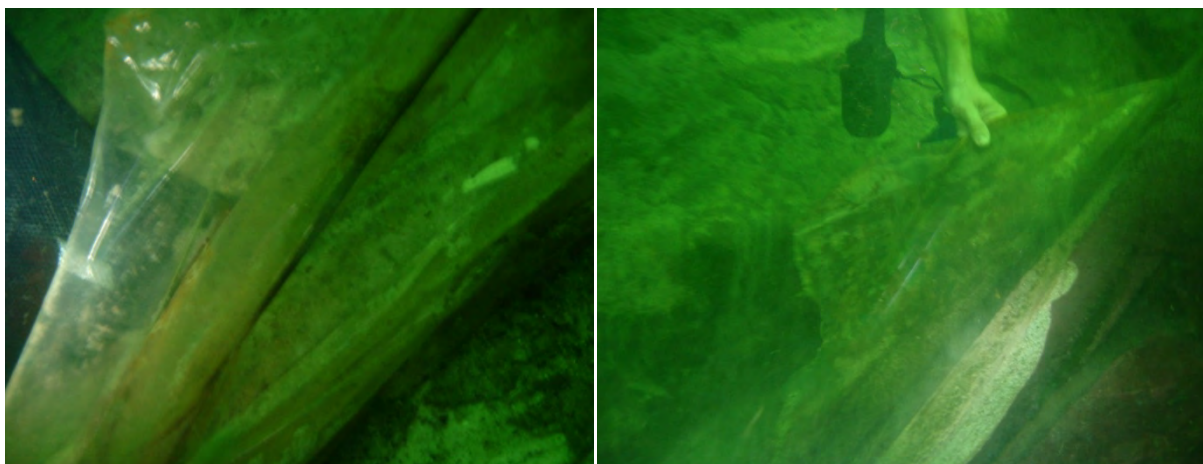
The liner was uniform in color, translucent and appeared to be in good condition, only one area close to the edge was fragmented, the depth of the liner varied from being totally exposed to buried up to a foot of sediment. One section seemed to be “bunched up and localized”; one section of the liner had a float attached (Figures 6 & 7).

Figures 6 & 7: Photographs showing the folded translucent plastic liner and where the fifth sample was collected.

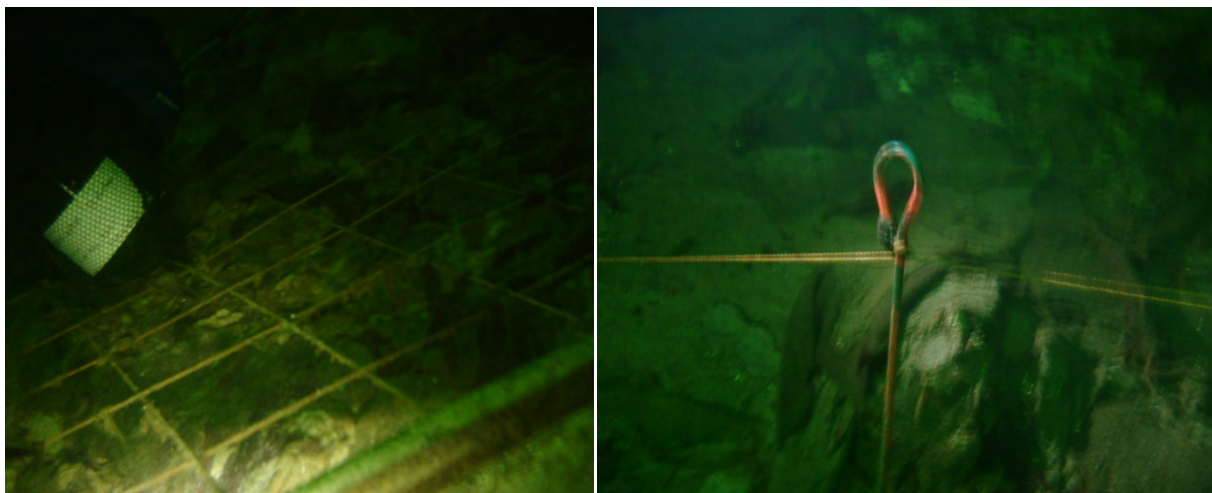
Upon further reconnaissance we found surveying quadrates and archeological grid with nylon rope held down with guide spikes, (Figures 8 and 9) survey flags with numbers written on them. Diverse debris surrounding the area, such as random rebar stakes, a 55 gallon drum which had a hole in it (with no visible signs of chemical leakage) and random bits of debris associated with public use.

Figures 8 & 9: Photographs showing quadrates and guide spikes.
