Biological Assessment of

Florida Cities Southgate Wastewater Treatment Plant

NPDES #FL0032808

February 1997

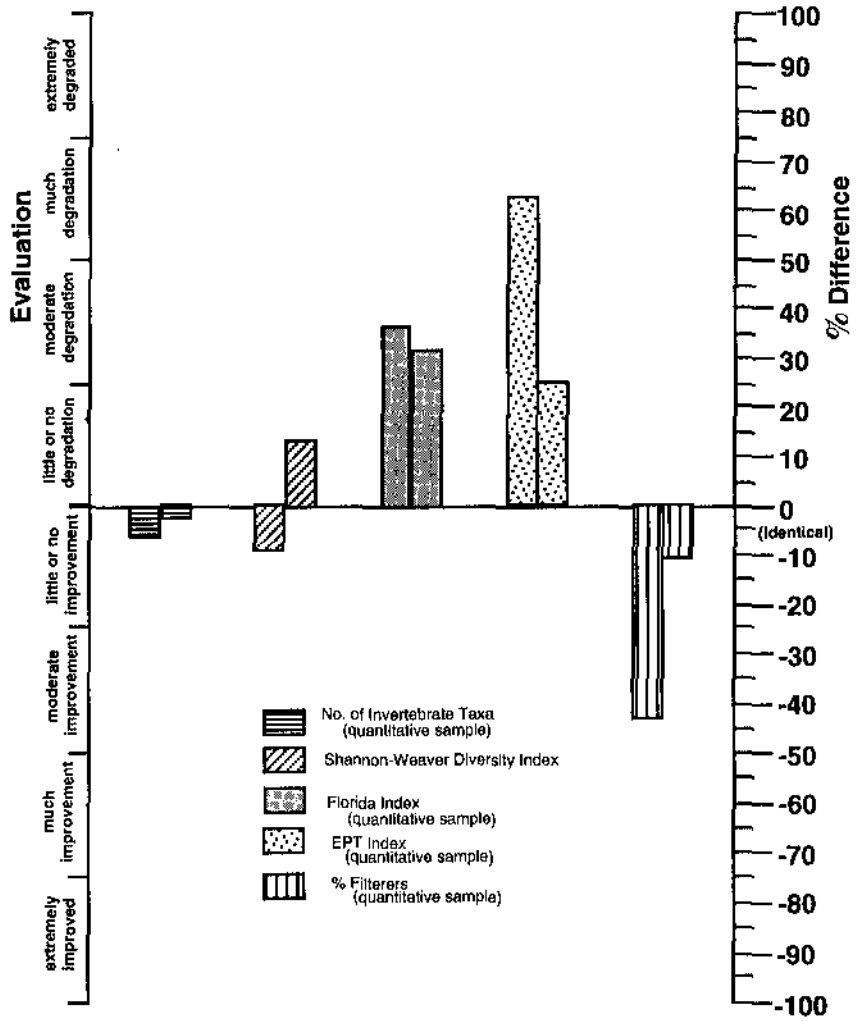
Effect of discharge on the benthic macroinvertebrate community.

The left bar for each parameter shows differences between the reference site and test site 1. The right bar shows differences between the reference site and test site 2.

health suggested only a moderate disturbance in the vicinity of the test sites. The figure on p. 2 indicates the degree of difference between the reference and test sites. Larger differences (that is, higher percentages) correspond with greater degrees of degradation. Negative values mean that the test site is better than the reference site.

In the Hester-Dendy samples, taxa richness (with 31 taxa at the reference site, 33 taxa at test site 1, and 32 taxa at test site 2) was very similar between stations. Following this same trend, Shannon-Weaver diversity values (3.3 at the reference site, 3.6 at test site 1, and 2.9 at test site 2) were comparable at all three sites. The Florida Index, however, was somewhat higher at the reference site (19), than at test site 1 (12), or test site 2 (13). The EPT Index was also higher at the reference site (8), than at either test site (3 at test site 1, and 6 at test site 2). The percent filter feeder metric was higher at test site 1 (35.9%) and test site 2 (27.8 %) than at the reference site (25.1%). It should be noted that there are many potential stressors operating on the system near the test sites (*e.g.*, suboptimal to marginal habitat, urban stormwater inputs). Based on the results of this survey and on past data, the Southgate WWTP effluent quality appears to be consistently good. Therefore, it is reasonable to conclude that other factors (stormwater, habitat) may be more responsible for the observed biological responses than was the discharge.

The dip net samples were mostly analogous to the Hester-Dendy results, except that test site 1 (upstream of the discharge) appeared to be more degraded than test site 2 (downstream of the discharge). The Stream Condition Index at the reference site (31) placed this station in the "excellent" category, while test site 1 (with an SCI score of 17) fell into the "poor" category and test site 2 (with an SCI of 25) was rated "good" (Appendix). As stated earlier, the lower SCI scores at the test sites could be due to a number of factors. There is an increase in urban stormwater inputs between the reference and test sites. While leaf packs, an important and productive substrate, were available at the reference site, they were absent from the test sites.

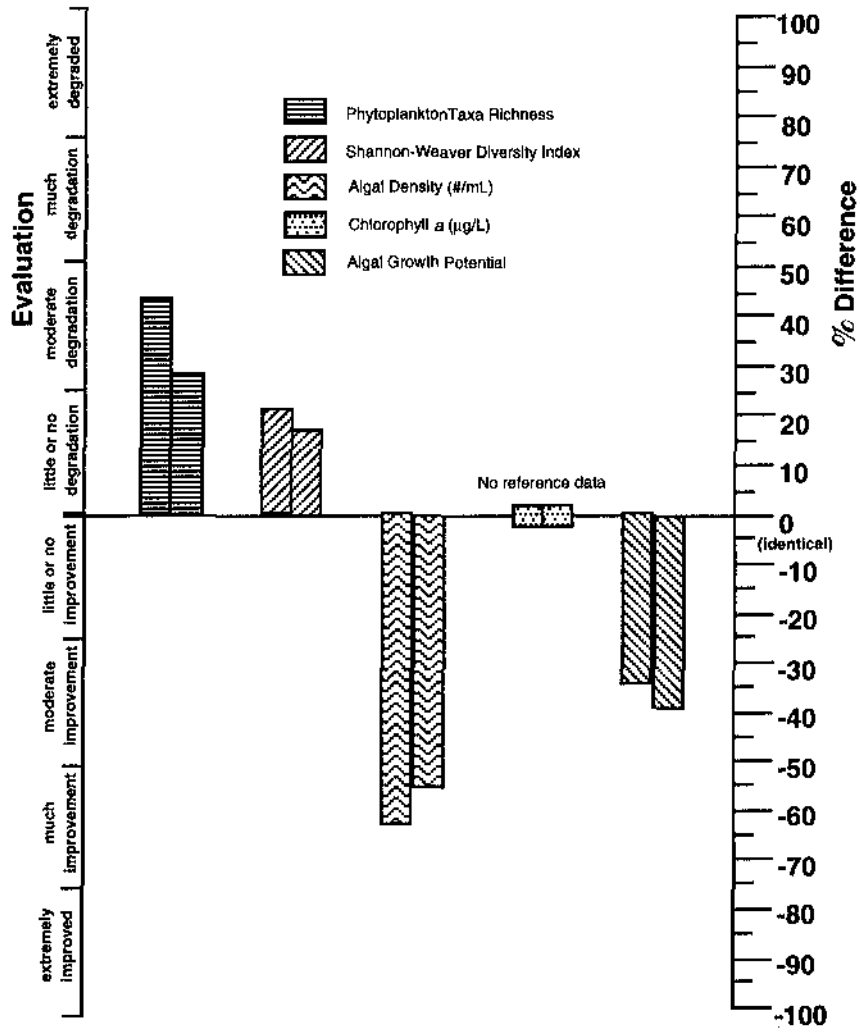
Effect of discharge on the algal community

(see figure on previous page for explanation).

Because periphyton racks were not recovered at the reference site, the phytoplankton populations will be addressed instead. The figure on p. 3 represents changes in the phytoplankton algal community. As was noted with the macroinvertebrates, larger differences (that is, higher percentages) correspond with greater degrees of degradation. The phytoplankton communities at all three sites were relatively depauperate. Taxa richness ranged from 14 taxa at the reference site to 8 taxa at test site 1. Chlorophyll *a* was undetected at the test sites, and not sampled at the reference site. Algal density ranged from a high of 746 cells/mL at the reference site to a low of 227 cells/mL at test site 1. Algal Shannon-Weaver diversity was 3.0 at the reference site, 2.4 at test site 1, and 2.5 at test site 2. Chlorophytes were the most abundant algal group at the reference site (46.5%), followed by euglenophytes (36.6%), while diatoms were most abundant at the test sites (70.0% to 74.1% of the total populations). In general, there was no evidence that the facility was negatively affecting the phytoplankton.
