**SARASOTA COUNTY**  
*"Dedicated to Quality Service"*

To: Board of County Commissioners  
Through: Robert Patten, Executive Director, ESBC *RP*  
From: *for E.S.W.* Eric Sutton, General Manager, Natural Resources, ESBC  
Subject: Board Assignment #05032 – Status of Beach Erosion and Nourishment  
in South Siesta Key  
Date: March 24, 2005

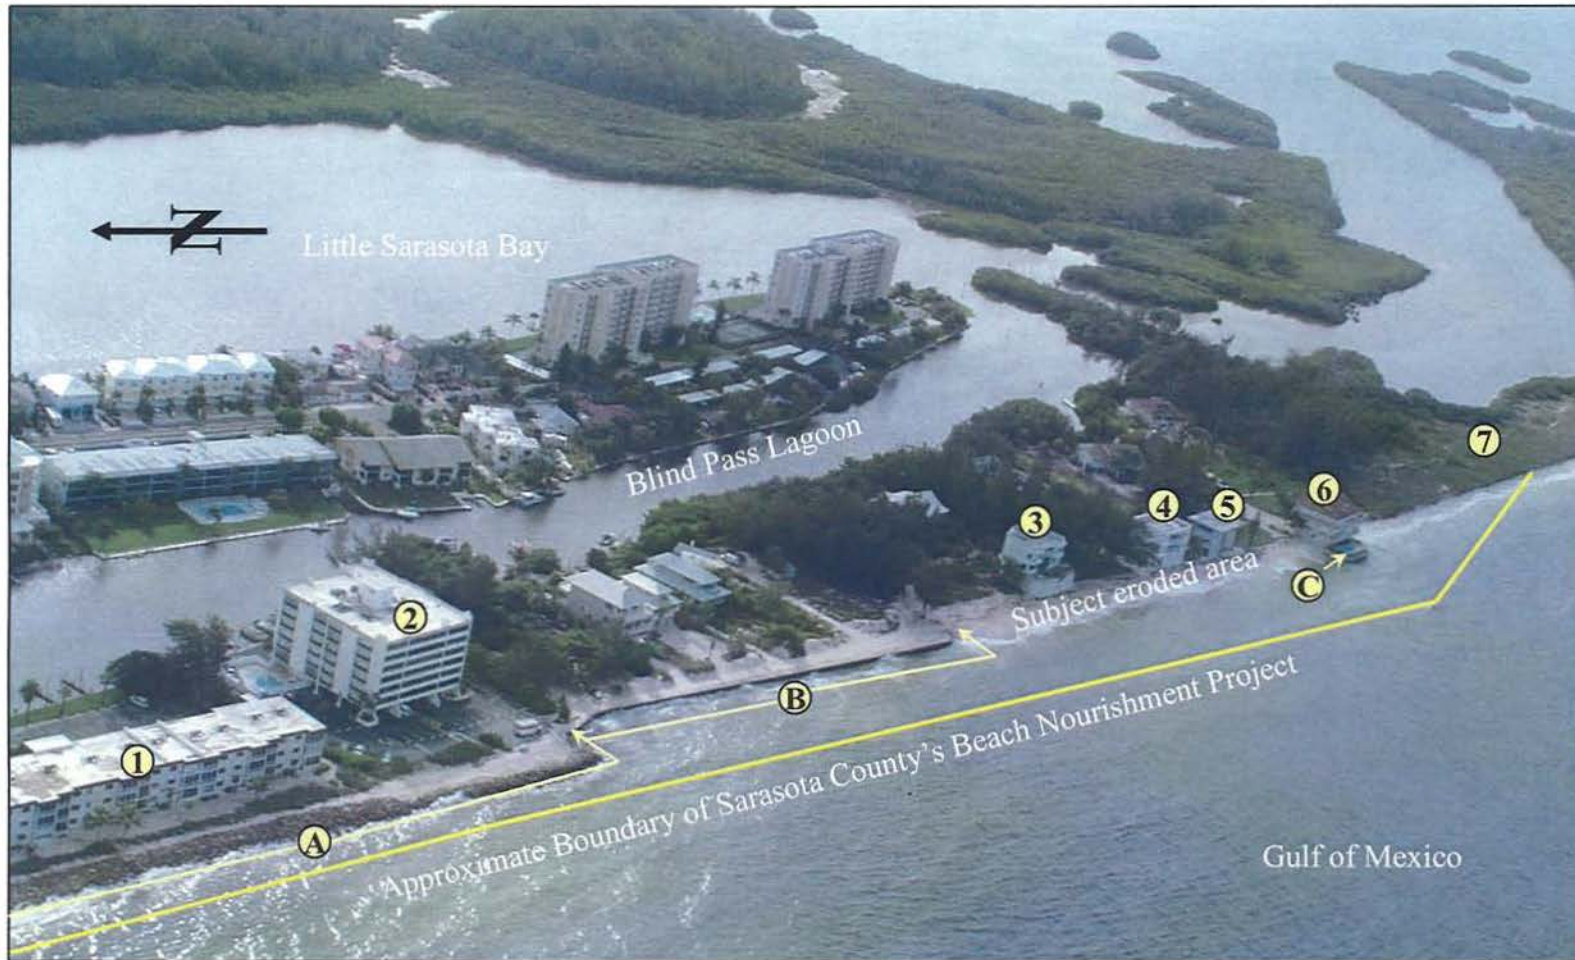
**Fig.1** An aerial view (August 12, 2004) shows the location of the subject South Siesta Key area. The listed gulf front properties are: (1) Fisherman's Cove Condominium; (2) Fisherman's Heaven Condominium; (3) Plodzien; (4) Fassy; (5) Burns' remaining house (No longer exists, demolished by the County in late October 2004); (6) Colkitt; and (7) Palmer Point Park. The listed shore protection structures are: (A) a 1100-foot long rock revetment; (B) a 510-foot long steel sheet-pile bulkhead; (C) a U-shaped aluminum bulkhead at Colkitt's gulf front house. The whole region is covered in the range of Sarasota County proposed beach nourishment project.

South Siesta Key beach (Fig.1) has undergone continuous erosion ever since the closure of Midnight Pass in 1983. The Florida Department of Environmental Protection (FDEP) estimated that an average of 5.3 feet of beach has eroded every year from 1987 to 2001 in this area. During this past winter, an acceleration of beach erosion was observed at the end of the Blind Pass bulkhead, north of 9250 (Plodzien) and 9200 (Fassy) Blind Pass Road (#3 & #4 in Fig.1). Over

Shoreline erosion on south Siesta Key has resulted in shoreline hardening as a response. Figure 1 shows three existing rigid shore protection structures (A, B, & C in Fig.1) in this area. In addition to a 1,100-foot long rock revetment in front of Fisherman's Cove and Fisherman's Haven Condominiums, a 510-foot long steel sheet-pile bulkhead along a portion of Blind Pass Road was constructed immediately south of the rock revetment in 2001. A U-shaped aluminum sheet-pile bulkhead was installed at 9230 (Colkitt) Blind Pass Road to protect a non-pile supported gulf front residence in May 2003. The County also has authorization to build a temporary 432 feet long aluminum bulkhead at Turtle Beach Public Park.

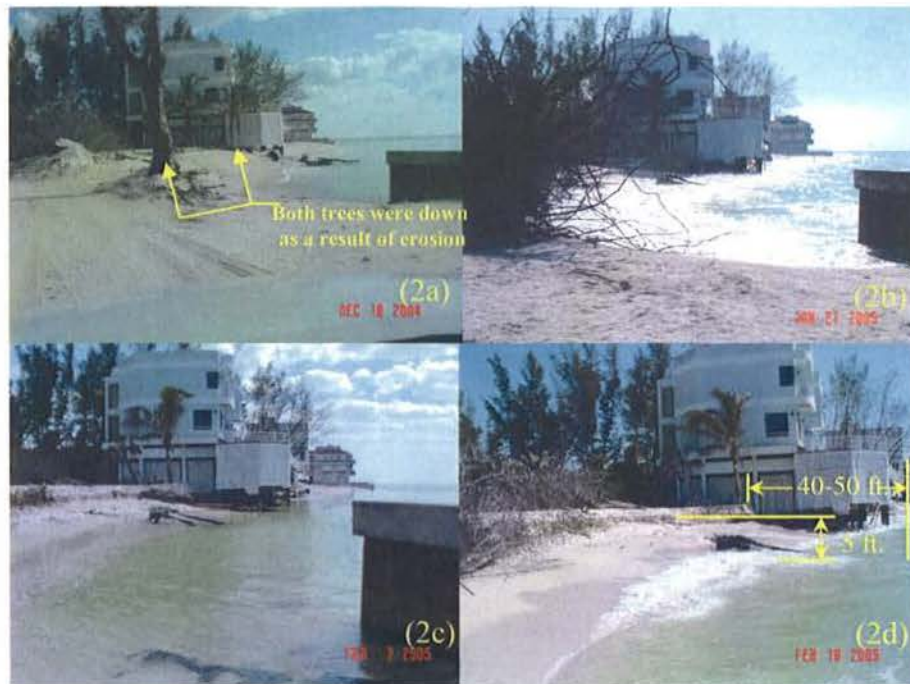
**Fig.2** An acceleration of beach erosion occurred at the end of the Blind Pass bulkhead, north of 9250 Blind Pass Road (Plodzien). From December 16, 2004 to February 18, 2005, an estimate of 40-50 feet wide and 3-5 feet height of beach erosion was observed in a two-months period, undermining the pile-supported house and threatening its entry way, septic system and the road.

a two-month period, about 40-50 feet of beach width and 3-5 feet of beach elevation is estimated to have been eroded at this location (Fig.2), causing a direct threat to the road (Fig.3). Waves also undermined both pile-supported residences, threatening their entryways, garages and septic systems (Figs.4&5).

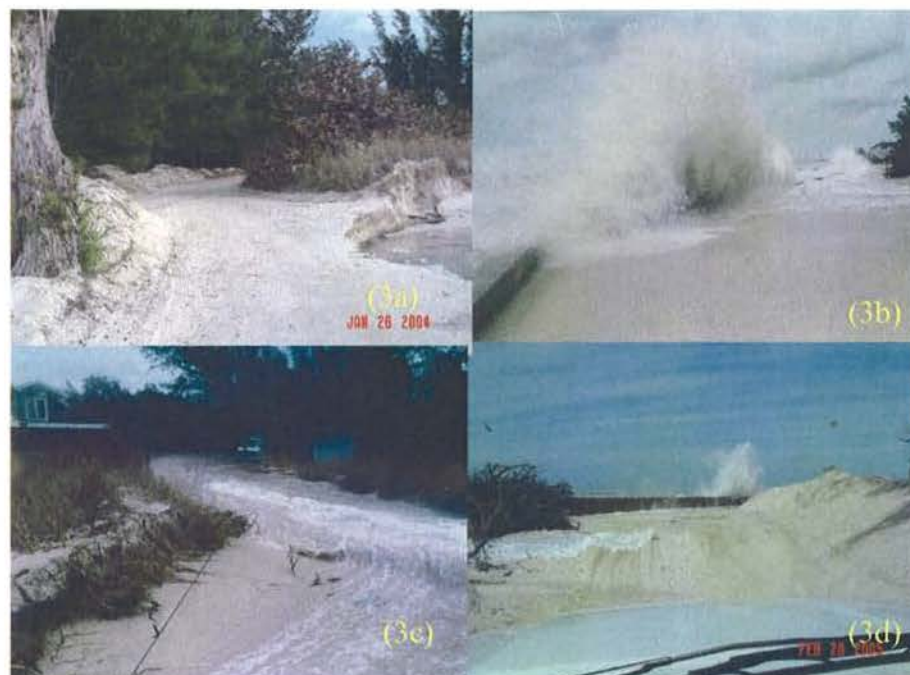
**Fig.3** Damage to the Blind Pass Road. (3a) Local scouring at the end of the bulkhead made the road un-passable last winter. (3b) Storm waves like this one destroyed a 275-foot concrete cap of the 510 feet long steel bulkhead (photo was taken on September 16, 2004 after Hurricane Ivan). (3c) Storm wave over-topped the bulkhead and washed portions of the road (photo was taken on September 16, 2004). (3d) The tree was washed out and the road is under direct threat.

- (1) Seek an administratively authorized *Emergency Class I* Coastal Setback Variance from the County for the use of temporary sand bags to protect ground-level residential entryways, garages and septic systems at the Plodzien and Fassy residences and any portions of the roadway that are directly and immediately anticipated to be damaged or destroyed. The preliminary feedback on this proposal that CR staff has received from the FDEP field engineer, Steve West, is that the agency would probably support such a project, but that it may require more formal authorization from their Tallahassee office.

- (2) Seek an *Emergency Class II* Coastal Setback Variance from the Board of County Commissioners for the use of a more substantial *temporary* shore protection structure to protect "vulnerable" portions of the road until beach nourishment occurs. Both the FDEP and CR staff would require that a professional coastal engineer be hired to prepare this application. FDEP would require a Coastal Construction Control Line (CCCL) Permit for such a project.

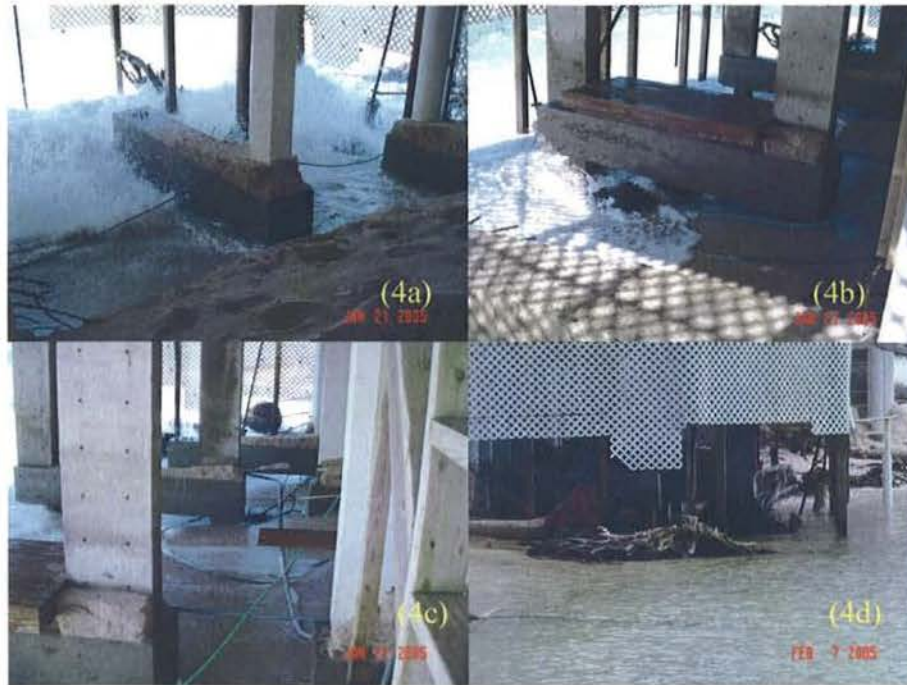
**Fig.4** Due to shoreline erosion, wave action undermined Mr. Plodzien's (#3 in Fig.1) pile-supported residence this winter. 4a, 4b&4c showed the pile caps were undermined by wave actions. (4d) The breakaway fence was damaged.

With regard to the protection of the Plodzien and Fassy residences, it should be noted that due to the adverse effects of permanent shore protection structures on coastal processes, the Sarasota County Coastal Setback Code and Chapter 62B-33 of the Florida Administrative Code (FAC) prohibit their use to protect structures that are neither "eligible" nor "vulnerable" under 62B-33 FAC. Both residences are located on a deep-pile supported foundation system and are therefore not eligible. For this reason, permanent coastal armoring may not be authorized by either the FDEP or the County to protect both residences.

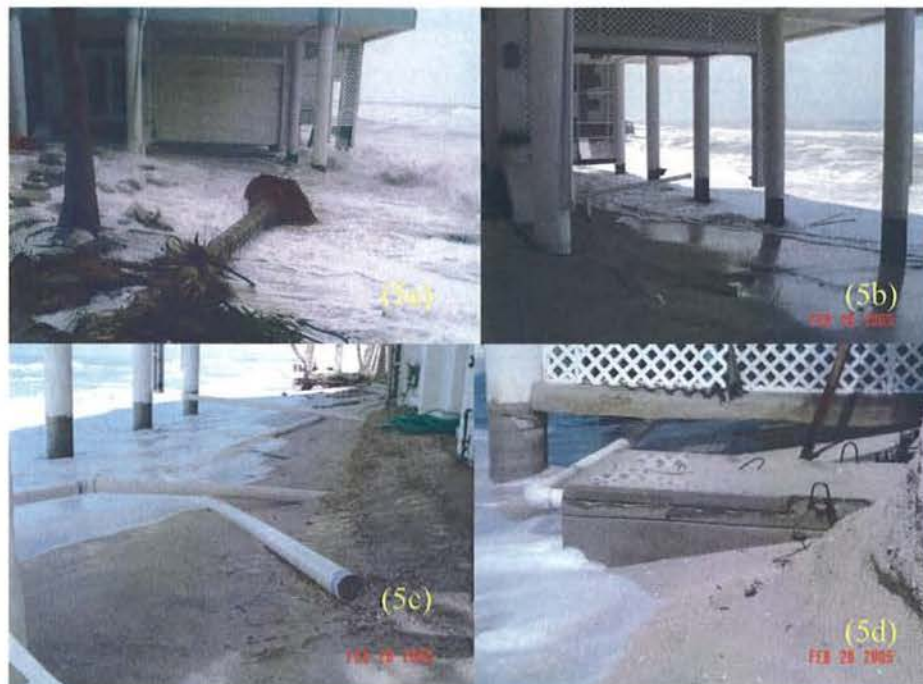
**Fig.5** Dr. Fassy's pile-supported residence was undermined by wave actions. (5a) & (5b) Former garage area was completely washed away, the entryway was directly under threat. (5c) Sewage pipes were washed out. (5d) Septic tank was exposed and under threat.

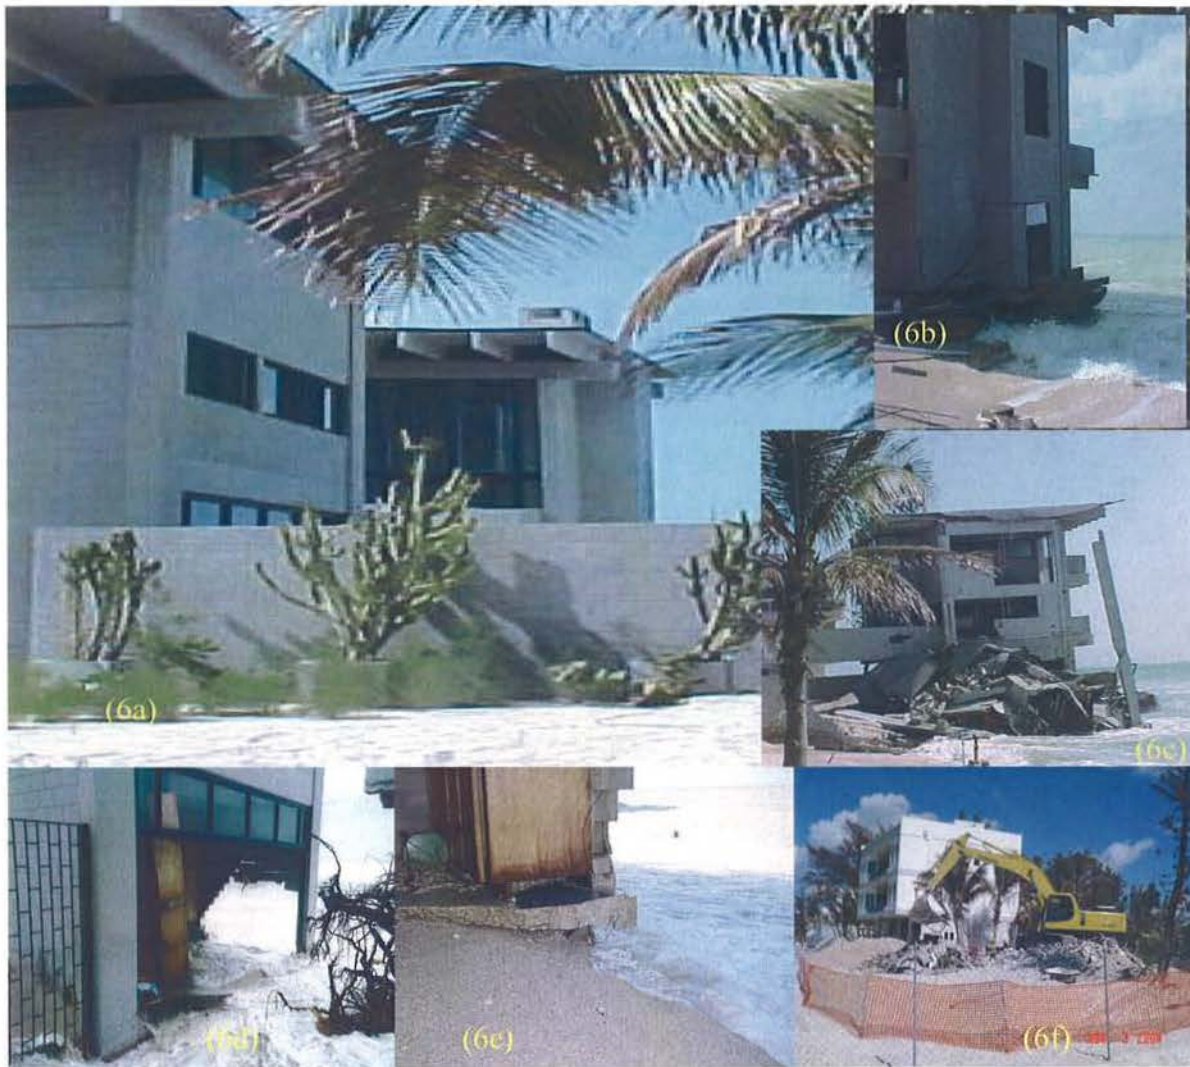
**Fig.6** As a result of beach erosion, one of the two Mrs.Burns' residences collapsed into the Gulf of Mexico in March 2003. Her second residence sustained structural damage in Hurricane Ivan and was demolished by the County in late October 2004. (6a) Burns' two residences before collapsed. (6b) Undermining of the foundation by wave action. (6c) The west portion of the residence collapsed, and the County removed the debris in March 2003. (6d) Storm waves washed out a portion of the front wall in Hurricane Ivan. (6e) Waves undermined the foundation. (6f) Pursuant to Sarasota County Building Code Section 22-34(3), the County demolished the second Burns' residence.

Coastal armoring did provide protection for some of the coastal properties in the region [e.g. Fisherman's Cove and Haven Condominiums (#1 & #2 in Fig.1)], but the armoring appears to have adversely affected neighboring properties by interrupting the littoral drift (alongshore sand transport) to the south and north. In March 2003, the seaward portion of a residence at 9210 (Burns) Blind Pass Road collapsed into the Gulf and was subsequently condemned and removed by the County (Fig.6). Last winter, portions of Blind Pass Road at the end of the bulkhead were eroded and not passable (Fig.3a). Residents were forced to reopen the road further north. During the 2004 Florida hurricane season, portions of the Colkitt's (9230 Blind Pass Road) aluminum bulkhead, pool, wood deck, and about 275-feet long concrete cap of the Blind Pass bulkhead were destroyed by storm waves (Figs.3b&7). Burns' remaining residence also sustained structural damage and was condemned and demolished by the County in late October 2004 (Fig.6f).

Right after Mrs. Burns' residence was demolished, local residents observed an acceleration of erosion and perceived that these two events were more than a coincidence. Staff strongly believes that this perception is incorrect for the following reasons: Burns' storm damaged residence, when demolished, was at least 20 feet away from the mean high water line. It never acted as a "groin" or a shore protection structure. It did not reflect any wave energy, nor interrupt the currents and sand transport in that region. The acceleration of the erosion is most likely a result of the adverse impacts of existing shoreline protection structures, in addition to the unstable nature of the beach after the closure of Midnight Pass in this area. North of this area, the rock revetment and the Blind Pass Bulkhead interrupt most of the sand transport from the north to south. South of this area, the location of Colkitt's bulkhead not only reflects wave energy, but also blocks sand transport from south to north, leaving this particular area as the most susceptible place for shoreline erosion. This trend is expected to continue in the future until the beach can be nourished.

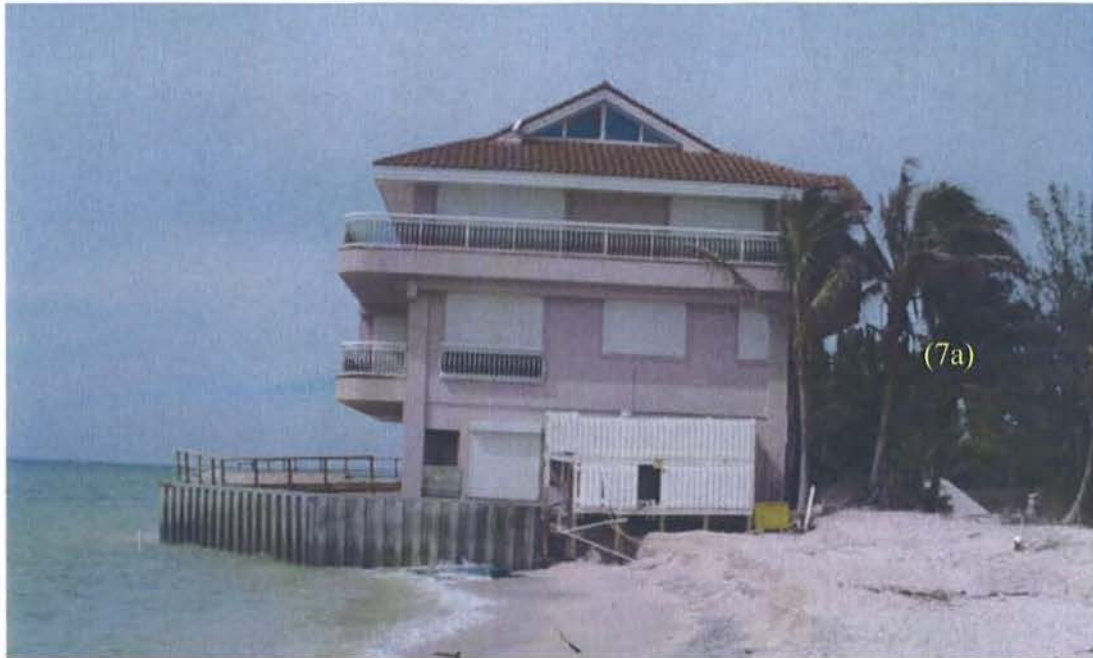
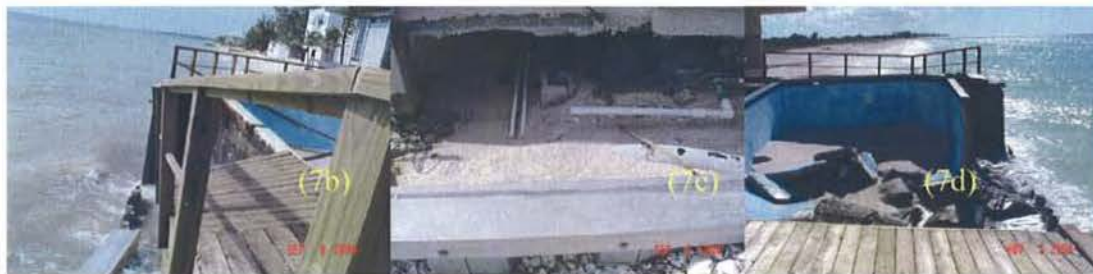
**Fig.7** Property damages at Colkitt's gulf front residence (#6 in Fig.1). (7a) Colkitt's residence at 9230 Blind Pass Road. (7b) An aluminum bulkhead, pool and wood deck were damaged during Tropical Storm Frances on September 3<sup>rd</sup>, 2004. (7c) House foundation was undermined by wave action. (7d) Aftermath after storm season.
